# POST-WILDFIRE NATURAL HAZARDS RISK ANALYSIS ARGENTA CREEK WILDFIRE (N71058)

**Sitkum Project No. 24-1990**

**March 31, 2025**

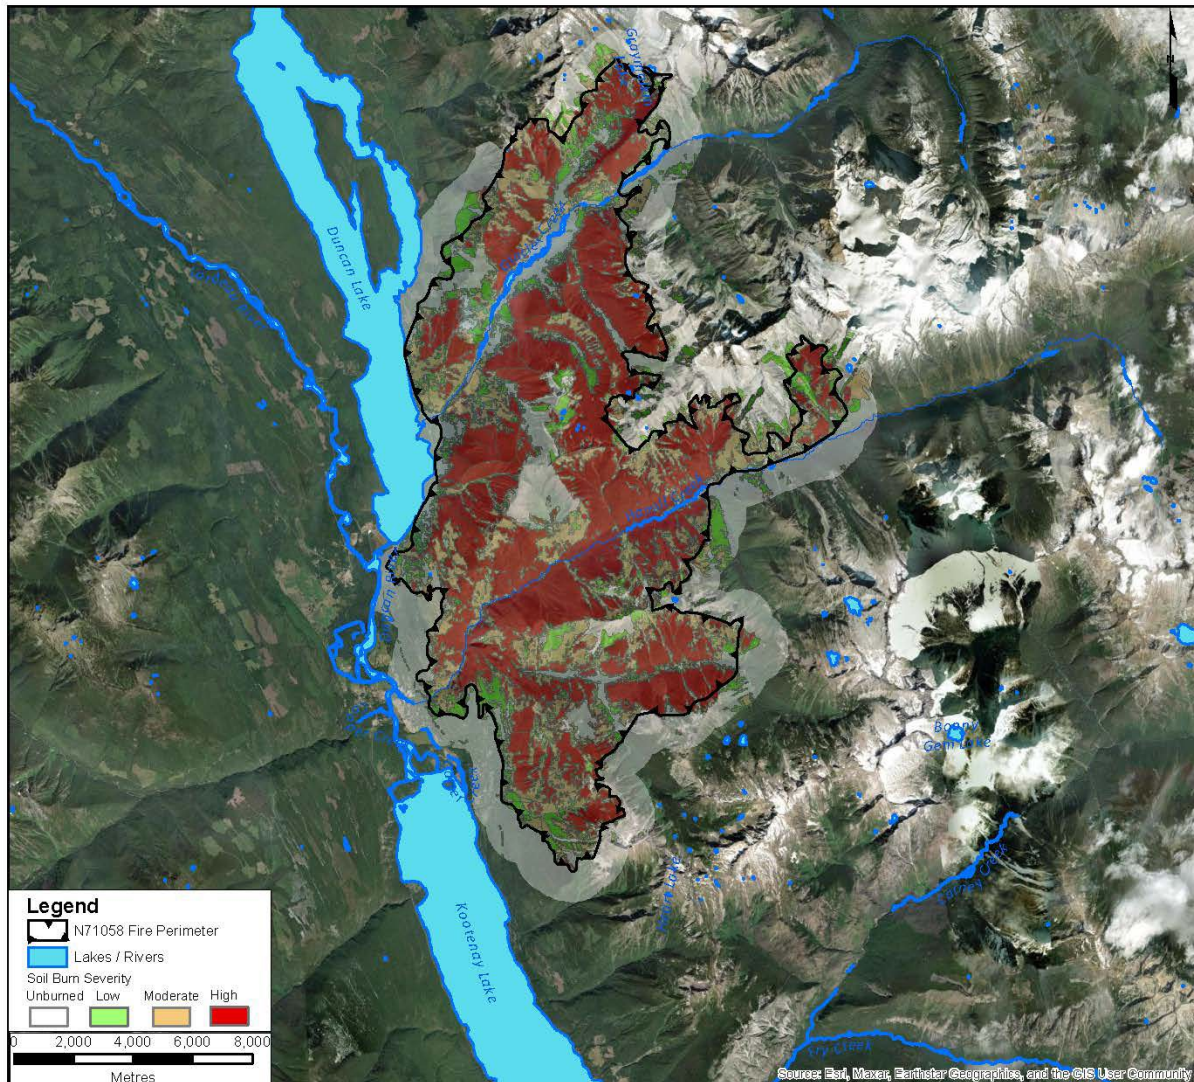
**Figure 7: Modified Soil Burn Severity Map**

- Argenta Creek area: based on field work and extrapolated to adjacent areas using the high resolution post-wildfire satellite imagery there was an increase in Low to Moderate soil burn severity in areas mapped as unburned by BARC;
- Clint Creek and Hamill Creek areas: the BARC mapping was found to be less reliable in alpine and treeline elevations, and modifications in terms of increasing and decreasing burn severity were made based on a combination of the helicopter overview flight observations and the high resolution post-wildfire satellite imagery; and
- Glacier Creek and Birnam Creek: based on observations from the helicopter flight in combination with ground observations there was generally an increase in soil burn severity in comparison with BARC mapping.

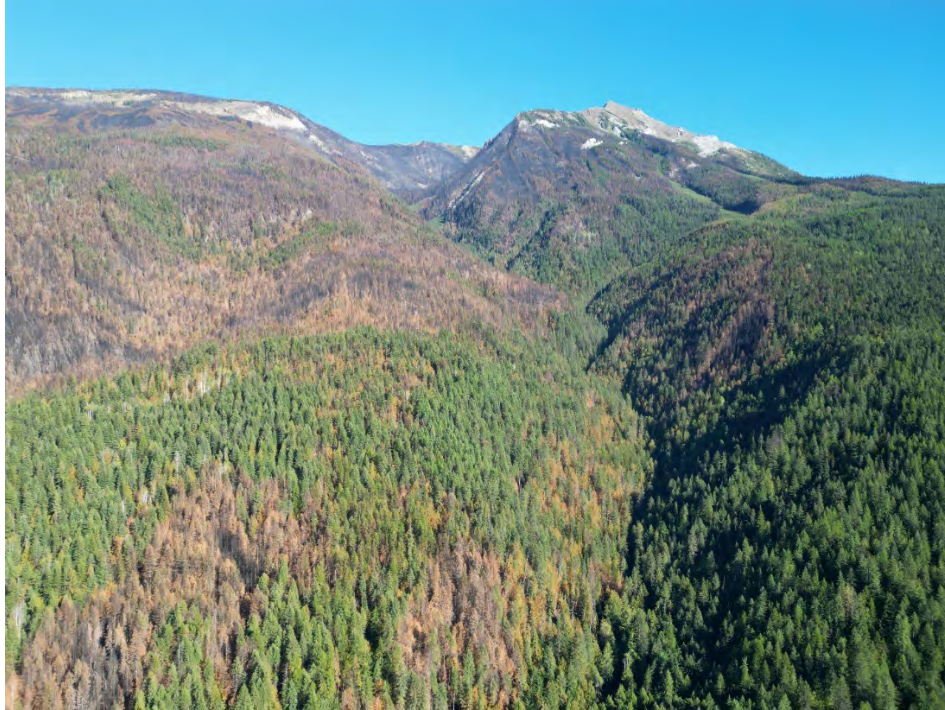
**Photo 1:** View looking up into Argenta Creek watershed with extent of high burn severity apparent in the upper elevations. Drone photo Sept. 16, 2024.

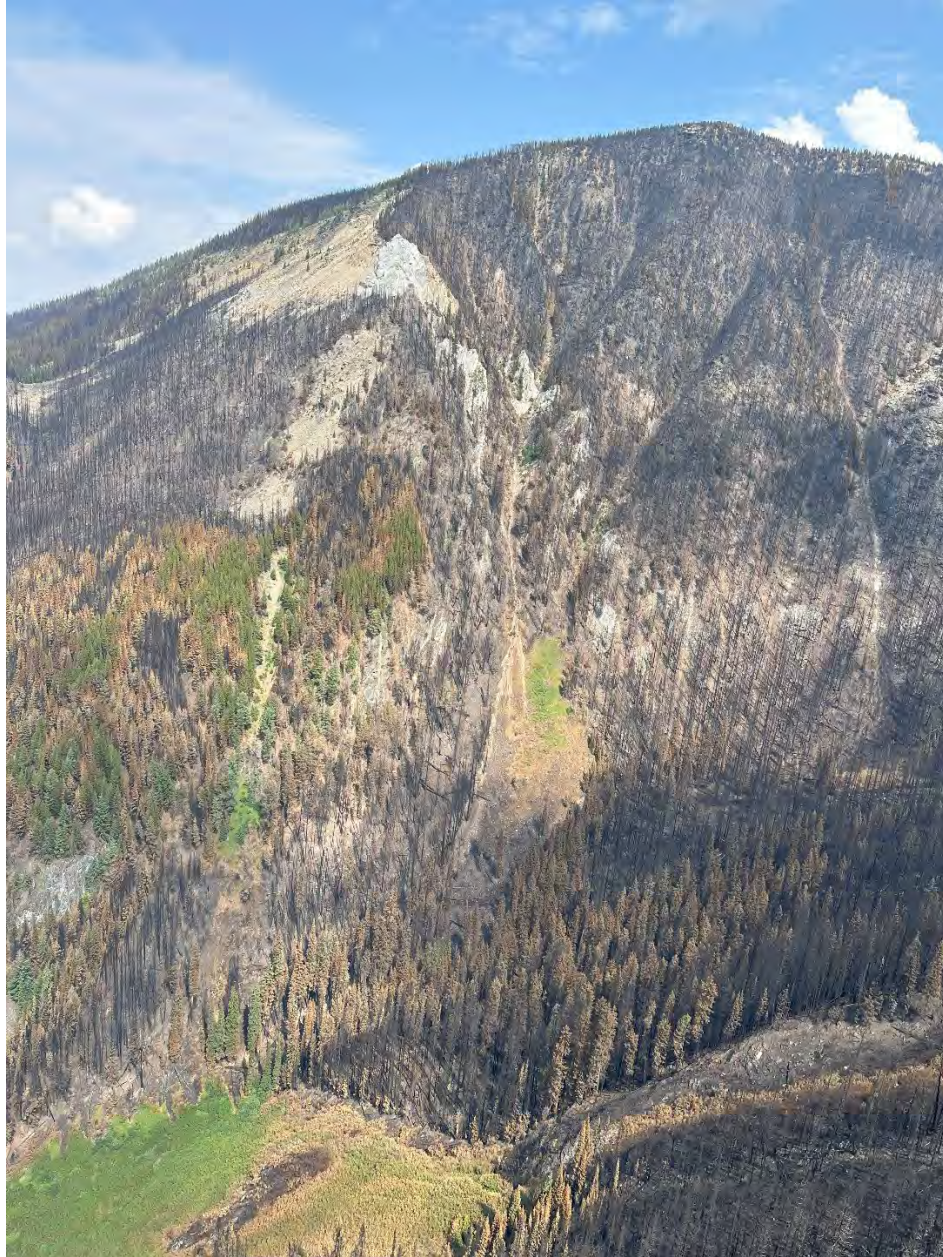
**Photo 3:** Recent debris flow tracks and deposits visible on southwest aspect slope in Argenta Creek drainage.

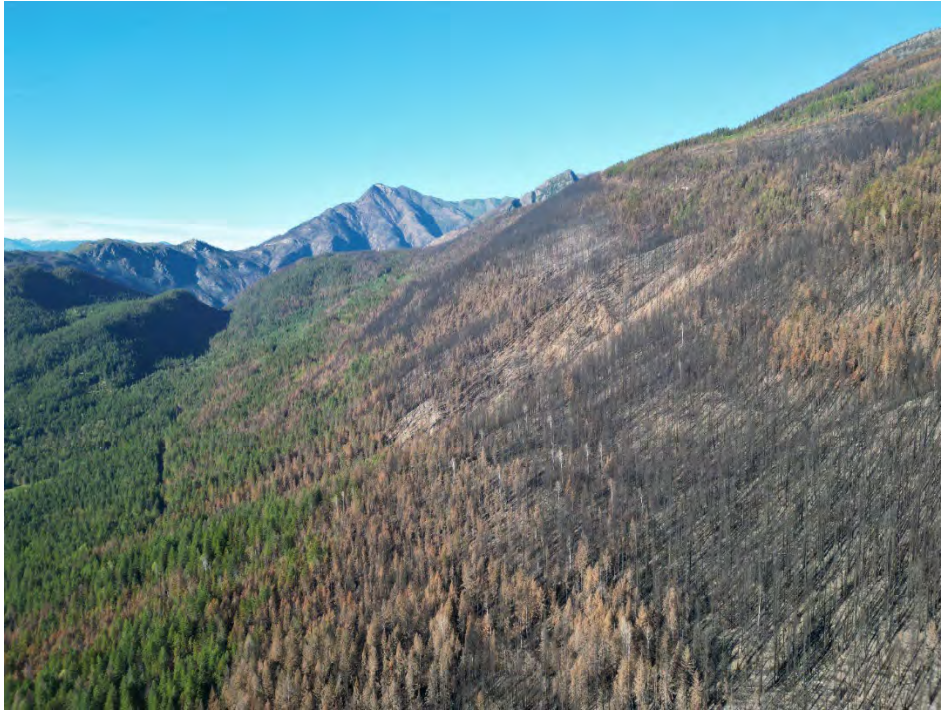
**Photo 6:** High burn severity band across Argenta-Carter Face, Sept. 16, 2024

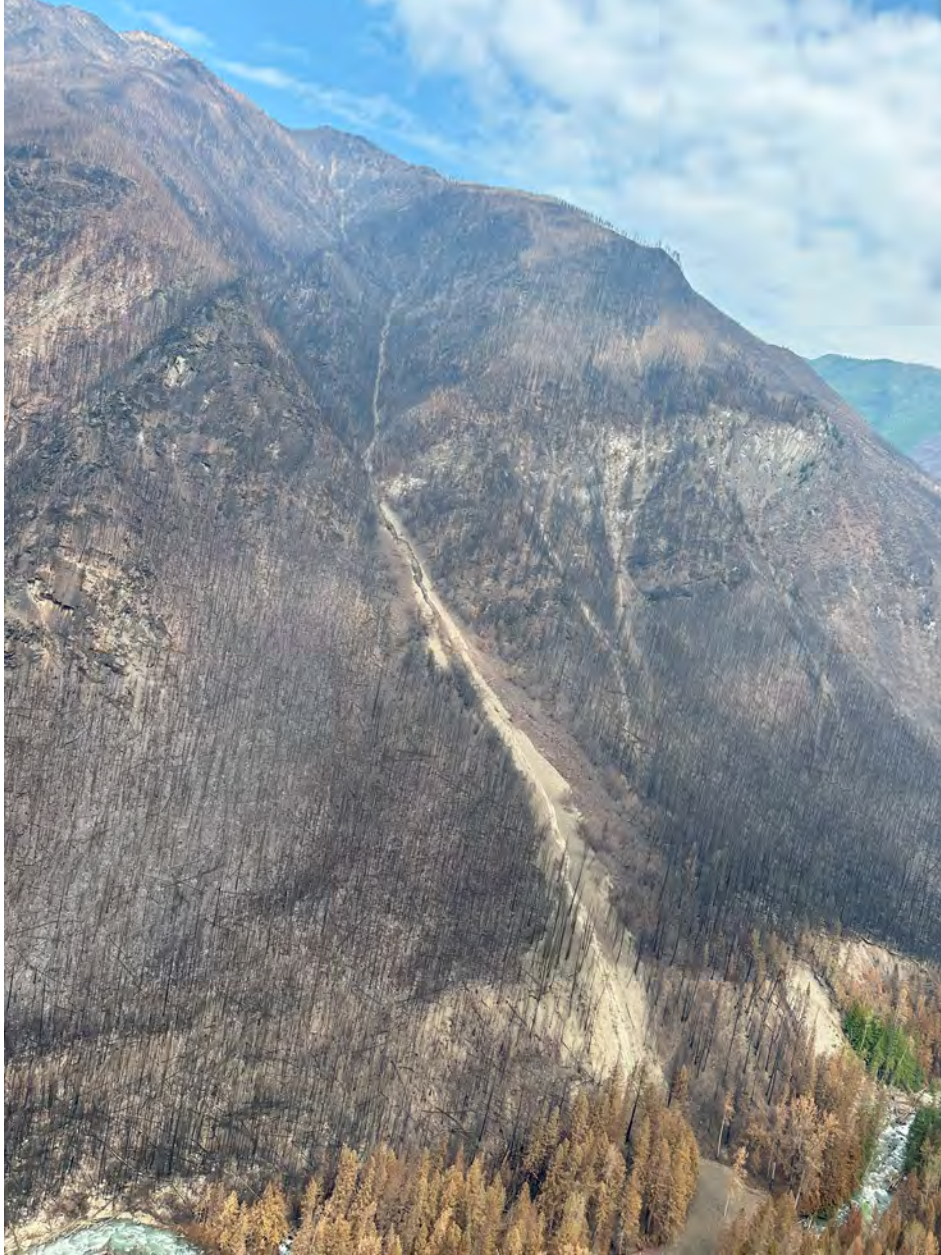
**Photo 8:** Recent debris flow activity in Hamill Creek; photo from helicopter overview flight Aug. 14, 2024.

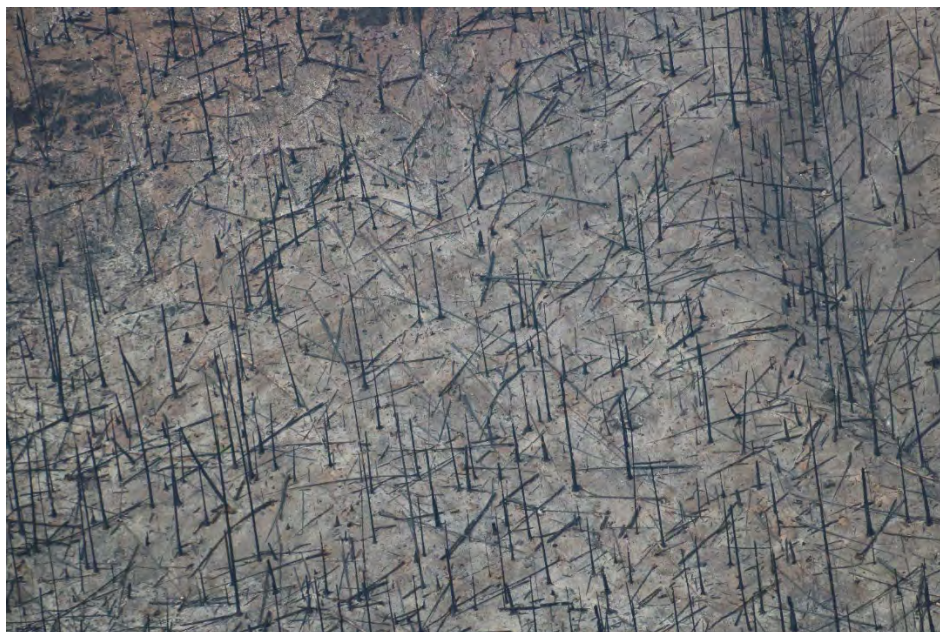
**Photo 9:** Example of high vegetation and soil burn severity in Hamill Creek, Photo from helicopter overview flight, Aug. 14, 2024.

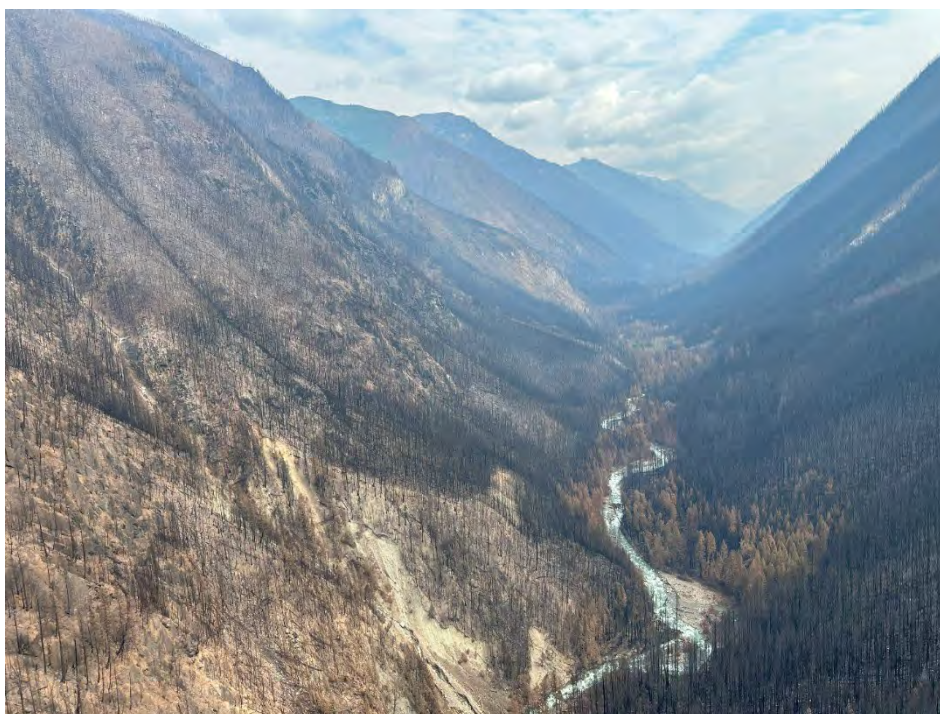
**Photo 10:** View upstream in Hamill Creek, note extent of moderate and high vegetation burn severity along valley bottom adjacent to creek. Photo from helicopter overview flight, August 14, 2024.

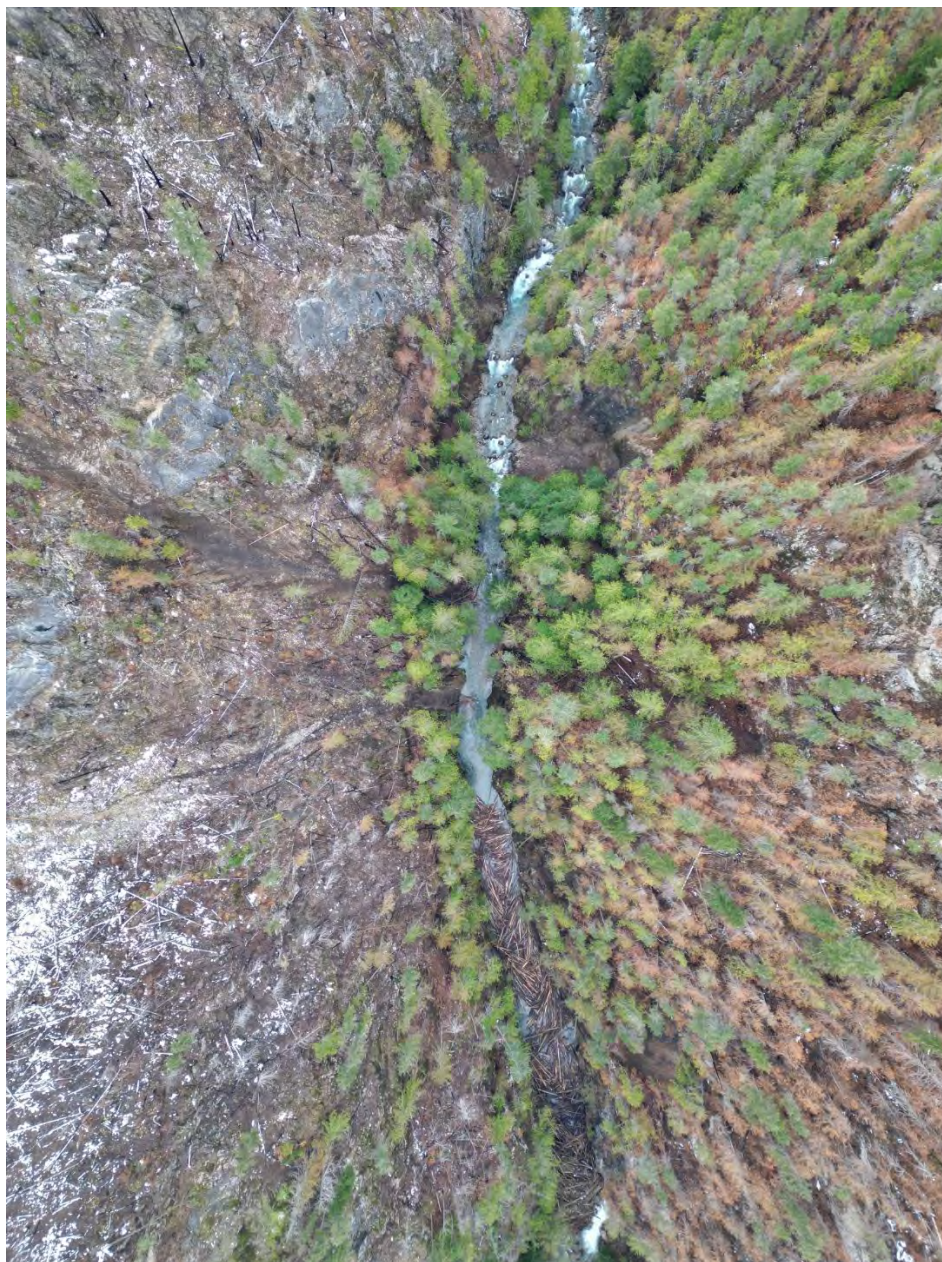
**Photo 11:** Log jam in Hamill Creek canyon; vertical orientation drone photo Dec. 2, 2024.

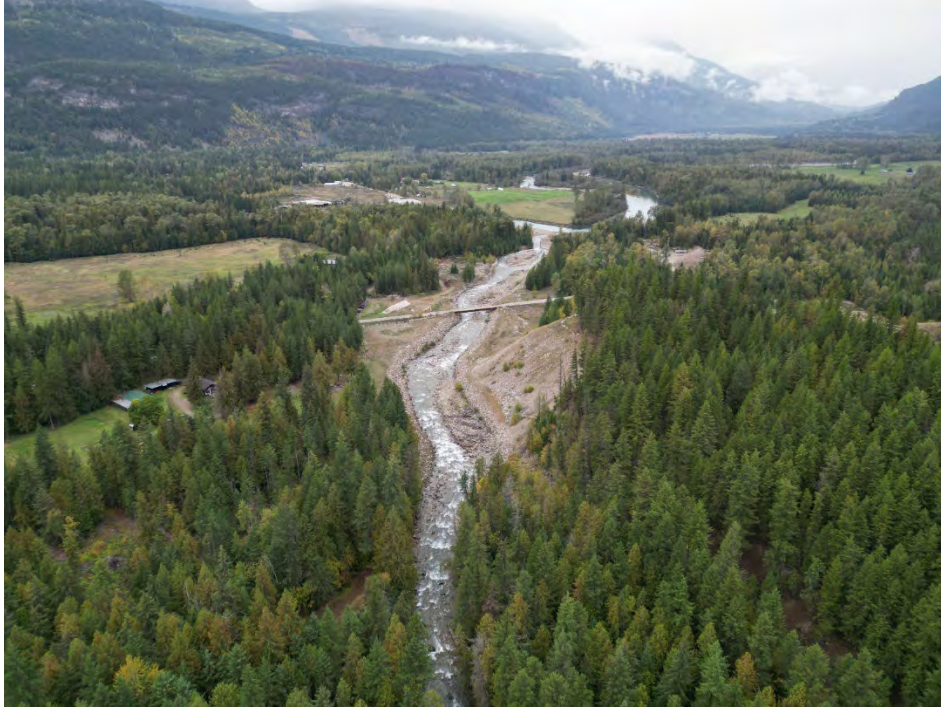
**Photo 12:** View downstream along Hamill Creek from near the apex of the fan. Duncan River FSR bridge and a portion of the fan is visible, along with stream training works along the creek channel which were installed in 2013 following a major flood event. Drone photo October 1, 2024.

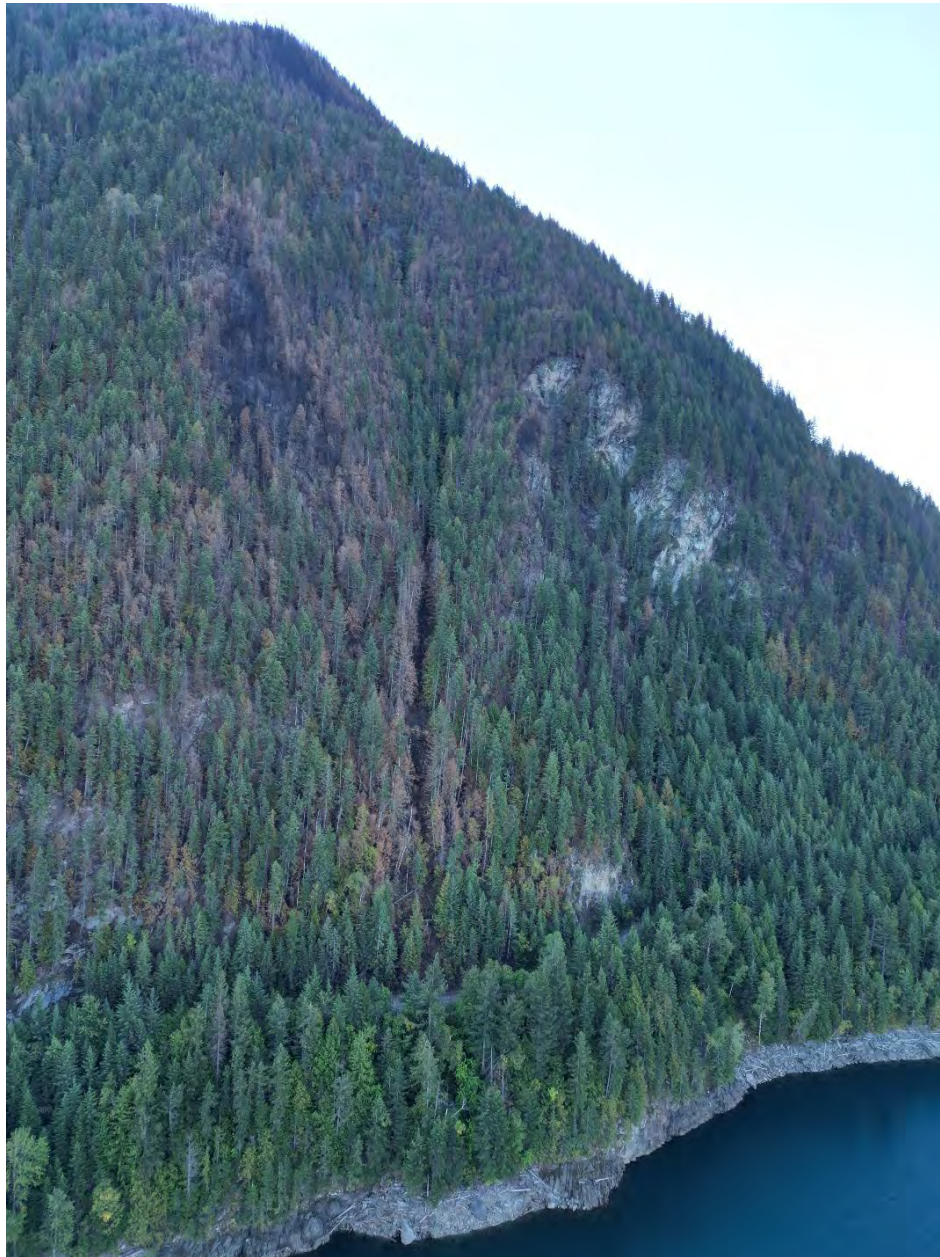
**Photo 14:** Duncan River FSR 6 km avalanche paths; drone photo Sept. 4, 2024.

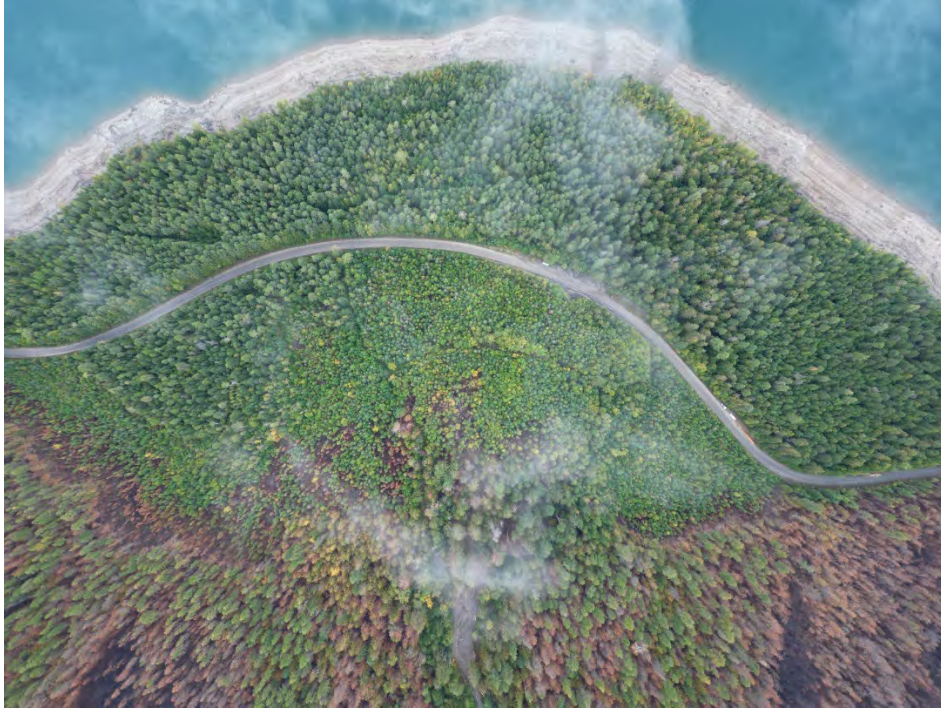
**Photo 15:** Lavina Creek fan with Duncan River FSR and debris flow deposit visible near apex; drone photo Oct. 1, 2024.

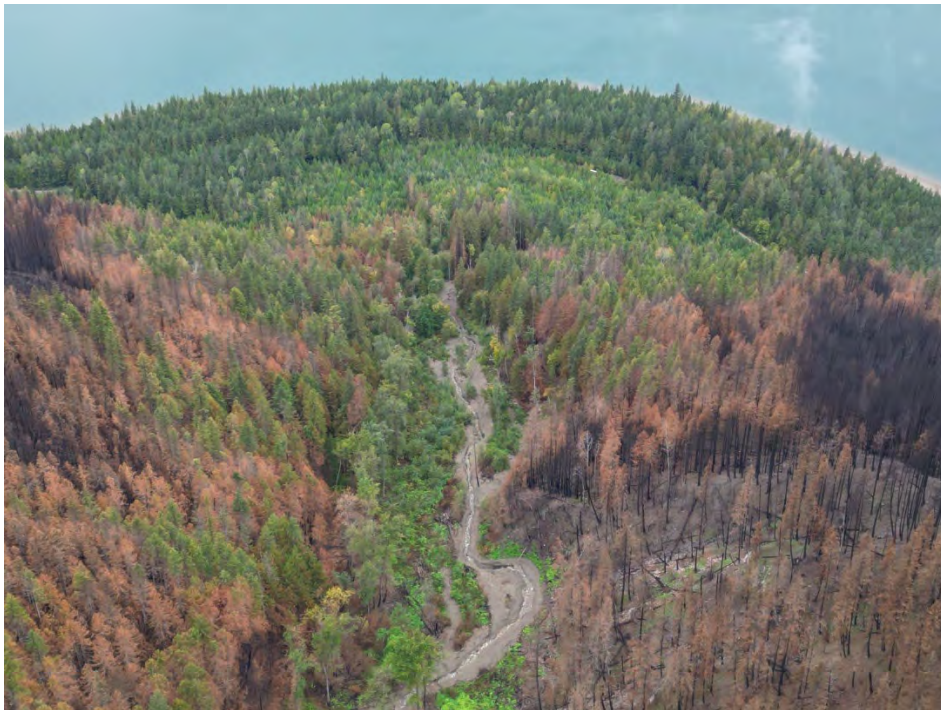
**Photo 16:** Lavina Creek fan with debris flow deposit near apex; drone photo Oct. 1, 2024.

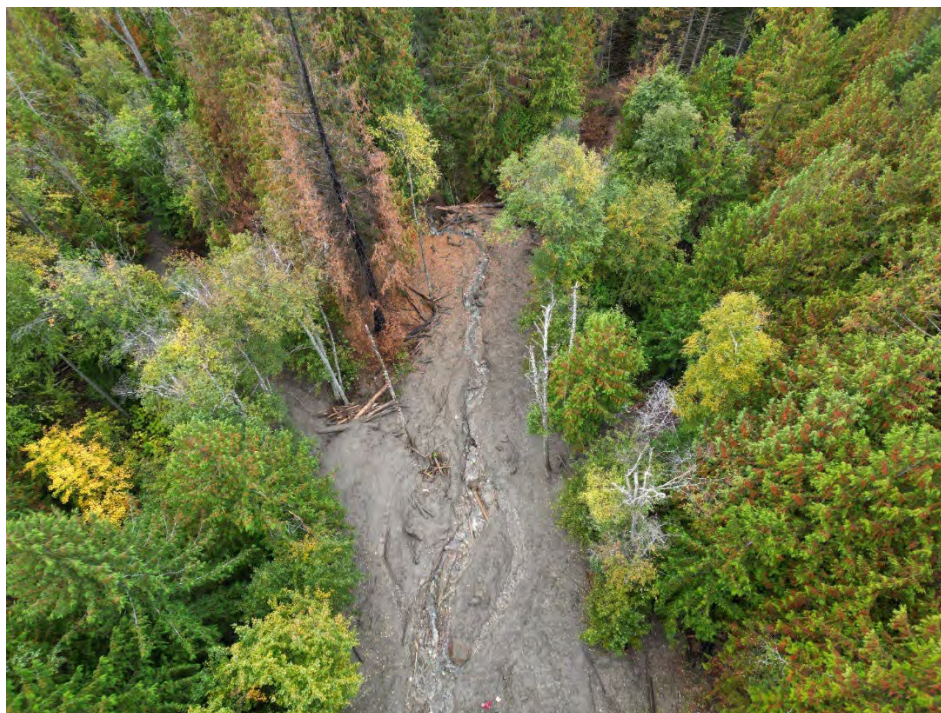
**Photo 17:** Lavina Creek debris flow deposit at apex of fan; drone photo Oct. 1, 2024.

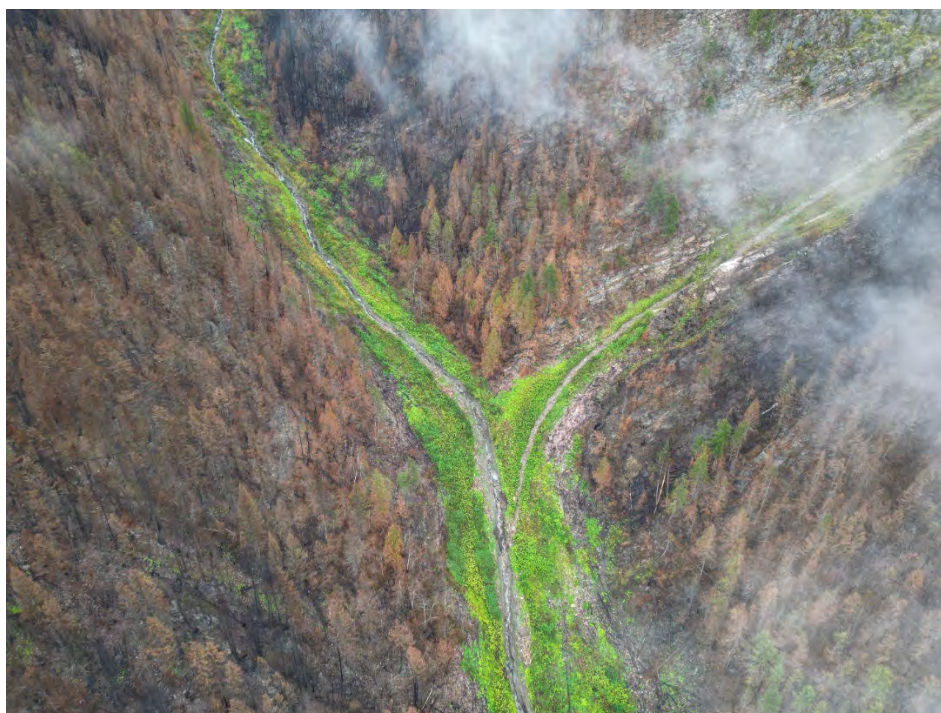
**Photo 18:** Converging debris flow paths in Lavina Creek watershed; drone photo Oct. 1, 2024.

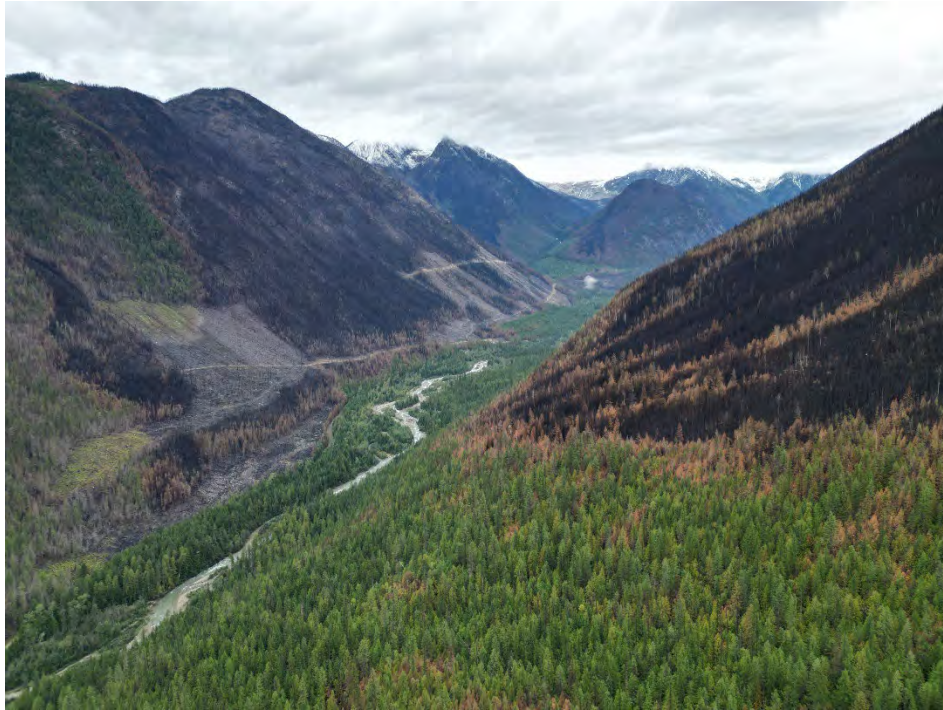
**Photo 19:** View looking upstream in Glacier Creek with Birnam Creek visible branching to the north (left) in the background. Note high burn severity on either side of valley, with low burn severity or unburned areas in valley bottom. August 28, 2024 drone photo.

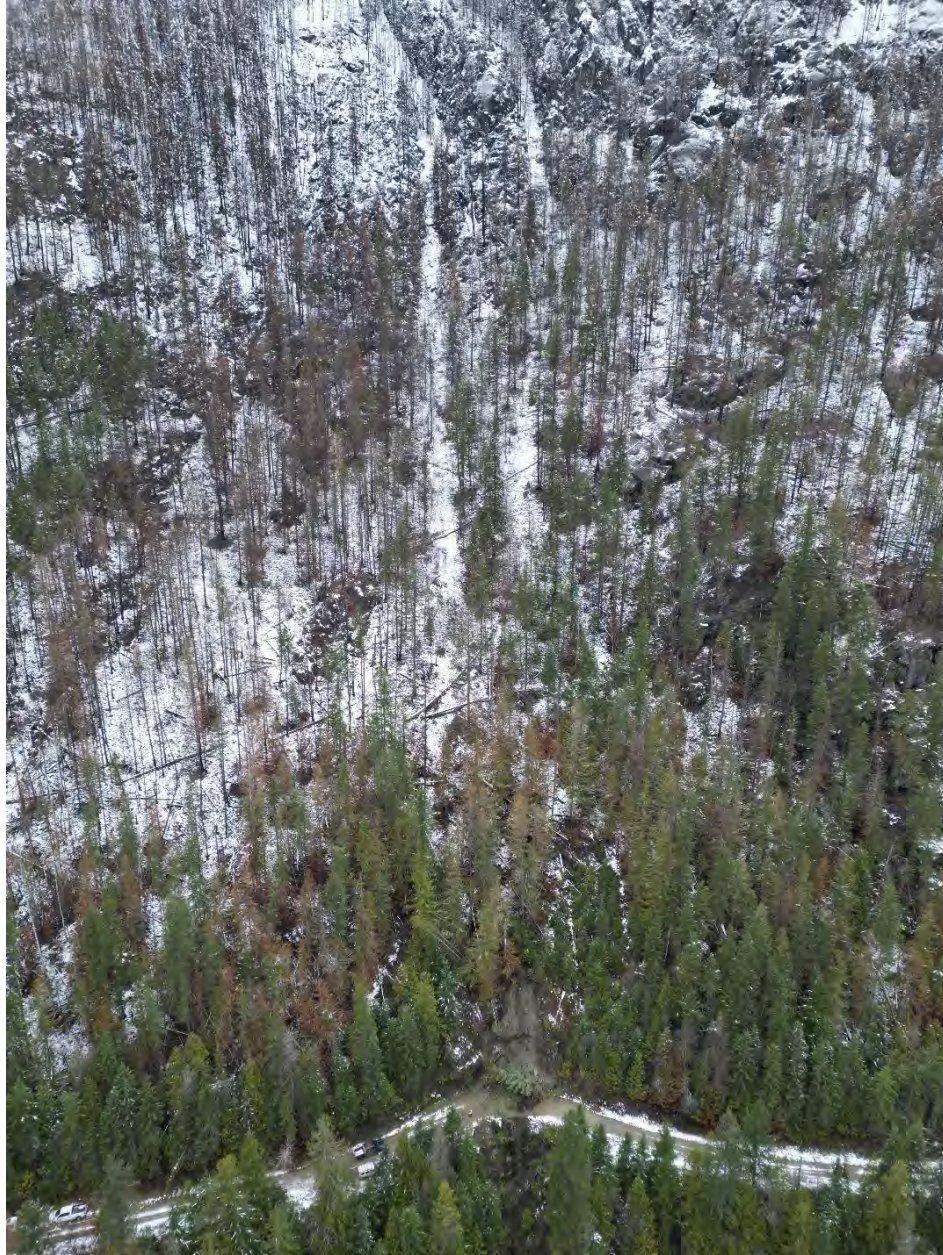
**Photo 20:** Avalanche path with recent debris slide blocking road at 12.3 km on Glacier Creek FSR. December 2, 2024.

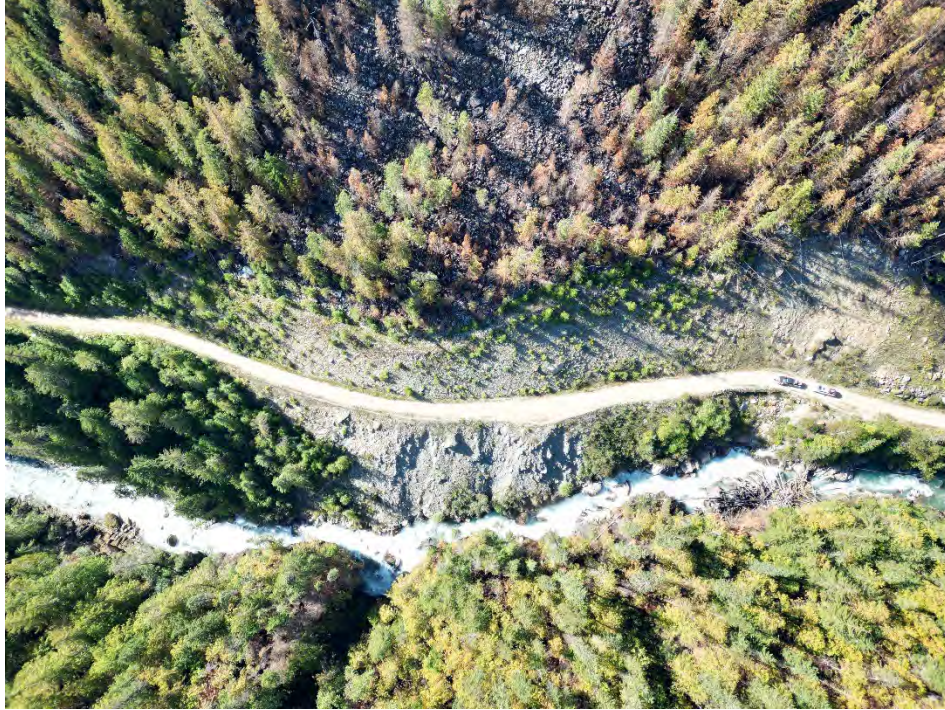
**Photo 21:** Drone photo with vertical orientation showing slow moving landslide area at 13 km on Glacier Creek FSR. August 29, 2024 photo.

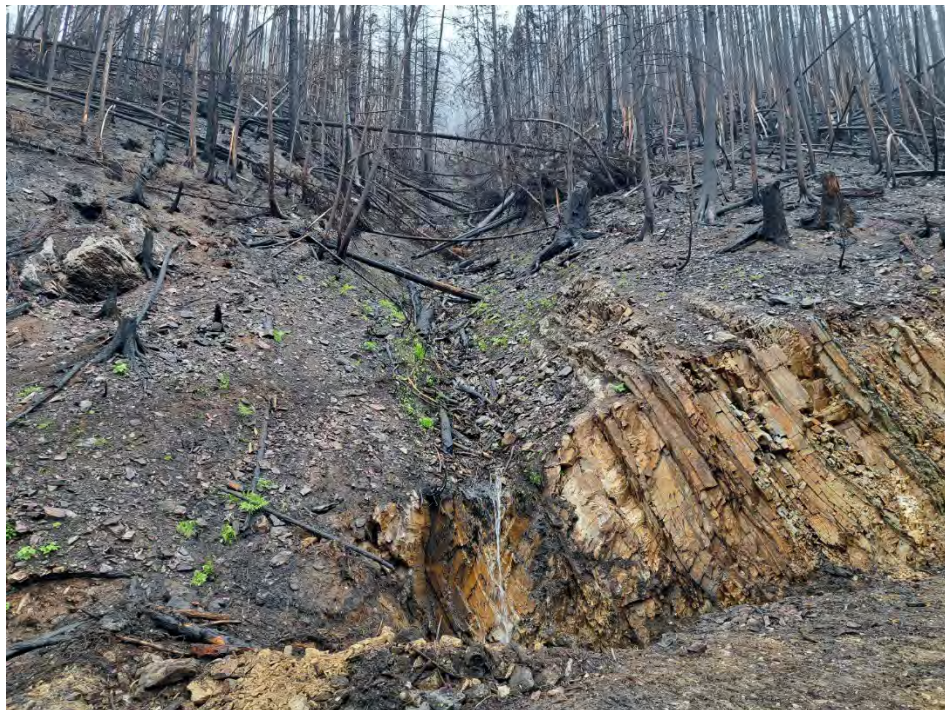
**Photo 22:** Shallow, steep gully susceptible to debris flows at Birnam FSR located within and downslope of a high burn severity area.

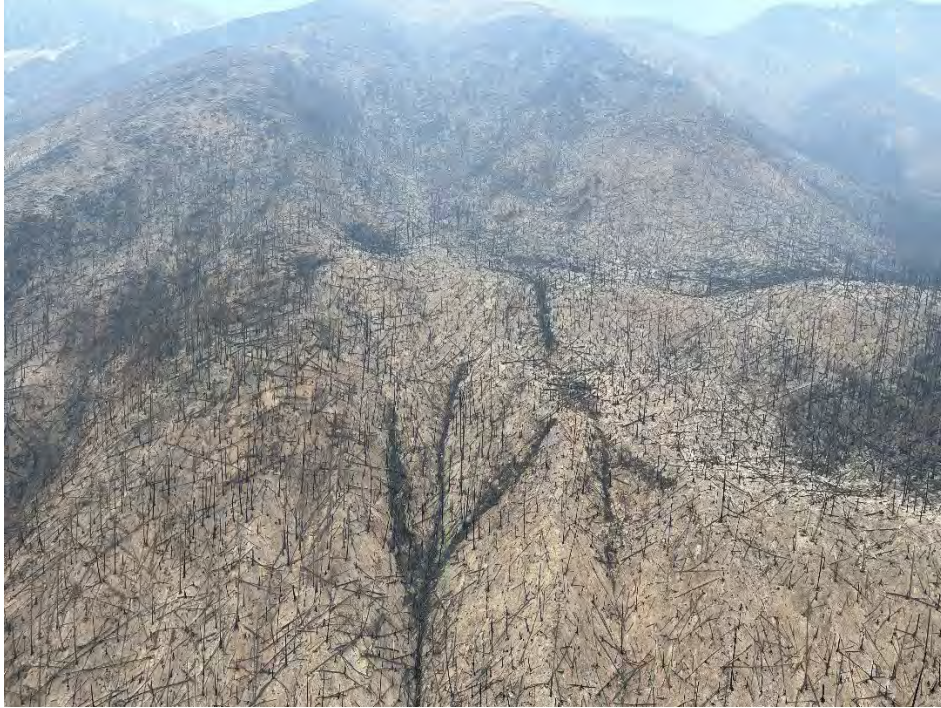
**Photo 23:** High vegetation and soil burn severity on the north side of Birnam Creek drainage in Glacier Creek watershed. August 14, 2024 photo from helicopter overview flight.

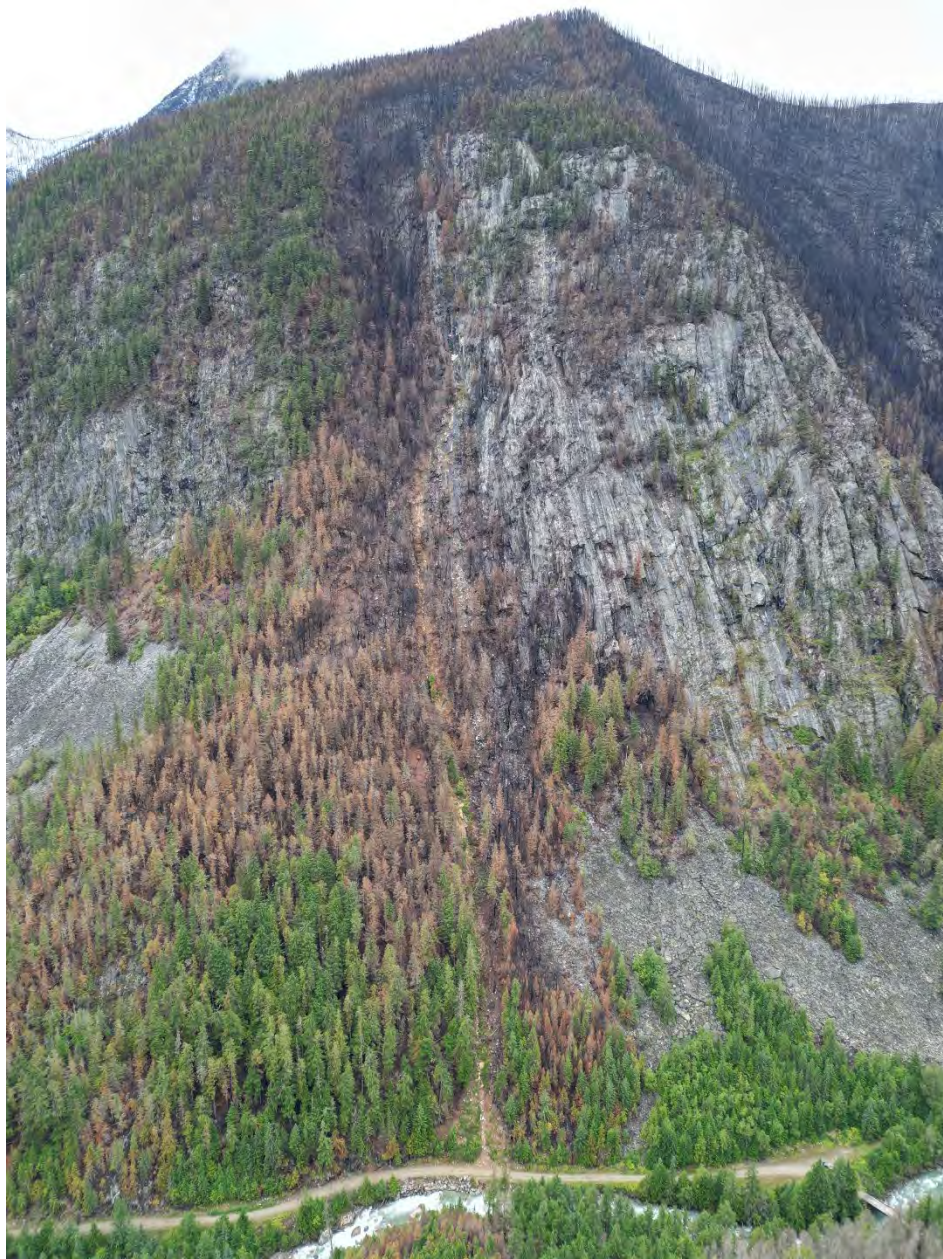
**Photo 24:** Narrow snow avalanche path also subject to small debris flows which impact Glacier FSR on north side of Glacier Creek near 1000 m elevation. An increase in frequency and magnitude of snow avalanches with increased debris loading in the snow can be expected here, as well as an increase in likelihood of small debris flows. August 28 2024 drone photo.

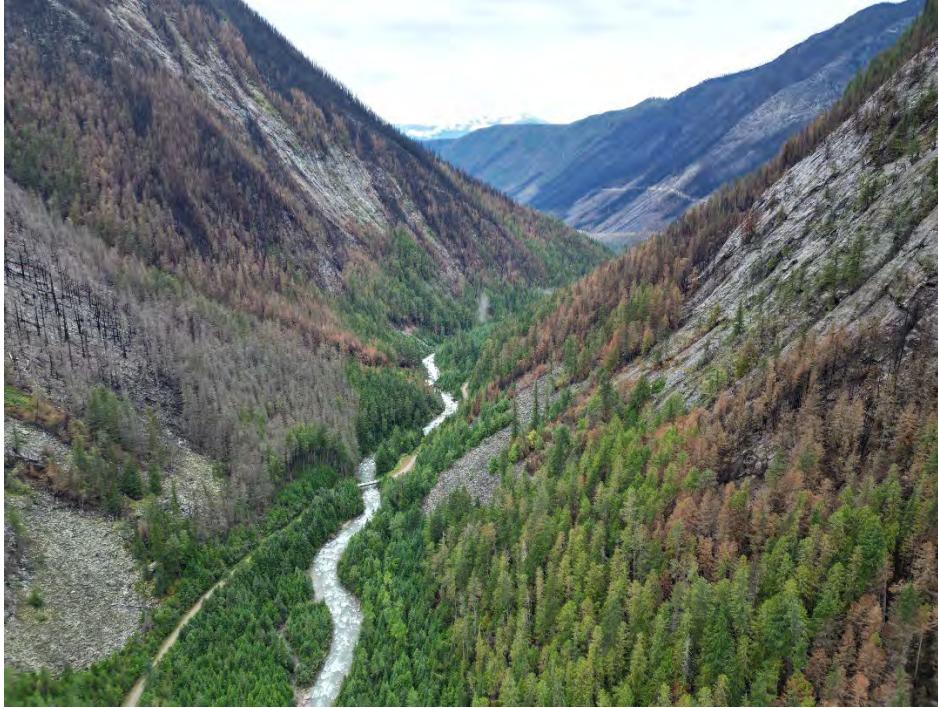
**Photo 25:** View downstream in Glacier Creek with Glacier Creek FSR bridge near 1000 m elevation. The bridge appears to have good clearance over a confined section of channel, reducing its vulnerability to flood events. August 28, 2024 drone photo.
