### TARRY'S FIRE HALL WINDOW REPLACEMENT PROJECT PRJ24054

#### ADDENDUM NO. 1

# 24017-TARRYS FIRE HALL

ASBESTOS, LEAD AND OTHER IDENTIFIED HAZARDS

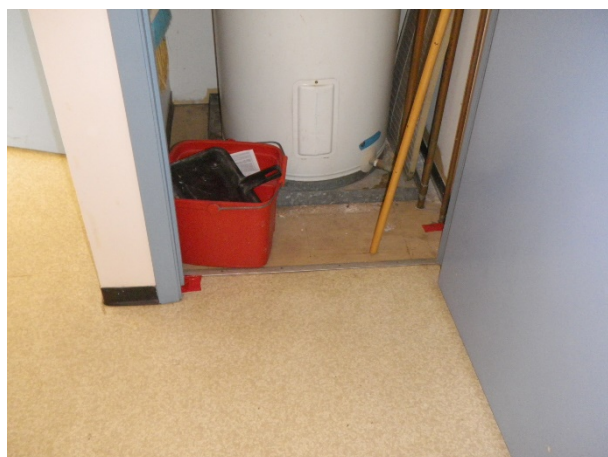
Figure 7: Sample 9; second floor men's washroom hot water tank storage room, west side, vinyl floor tile, beige 1'x1' (1% chrysotile asbestos)

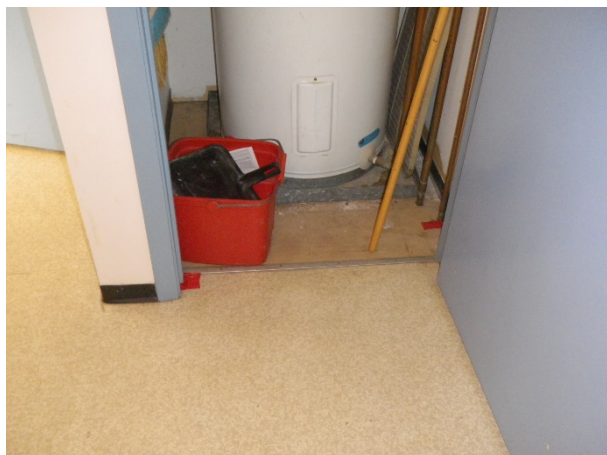
Of all the materials sampled, the material that is friable and has the greatest potential for fibre release is the sheet vinyl flooring in the North Shore fire hall second floor men's washroom and the exterior cinder block walls for Pass Creek and Tarry's fire halls. The flooring is covered with a vinyl substrate so no exposed paper backing was noted. All vermiculite insulation was encased in cinder block walls.

*Friability:* The sheet vinyl flooring paper backing is friable but is covered with a vinyl top. The vermiculite insulation is friable but is enclosed in cinder block walls. All other materials are non-friable unless broken or mechanically abraded.

**Figure 9: Sample 11, 2nd floor men's washroom at storage room by door, sheet vinyl flooring, beige pebble pattern (40% chrysotile asbestos)**

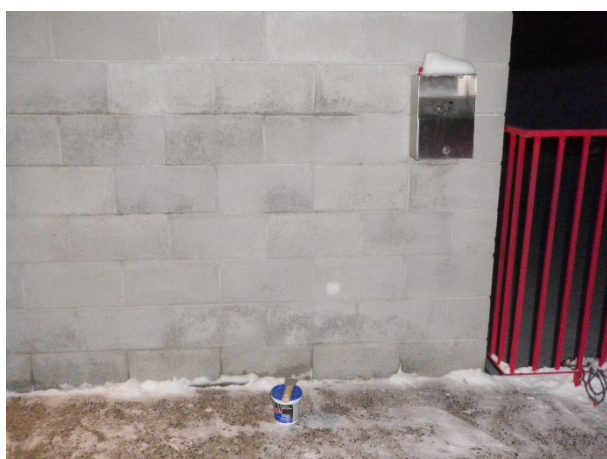
Figure 70: Sample 15, 2nd floor, patio off recreation room, exterior cinder block wall vermiculite insulation (trace actinolite asbestos)

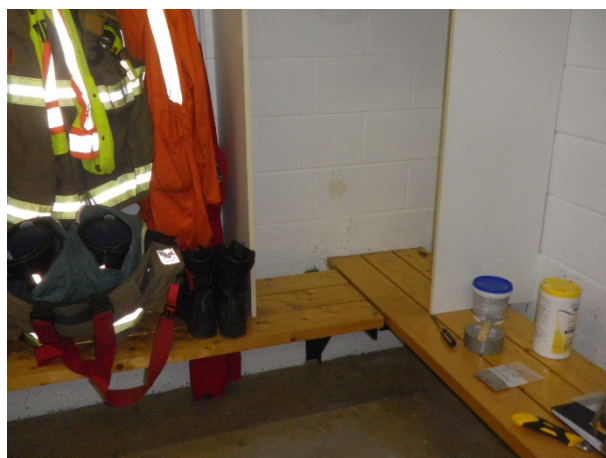
**Figure 71: Sample 1, main floor main bay, SW corner, vermiculite insulation (trace actinolite asbestos)**

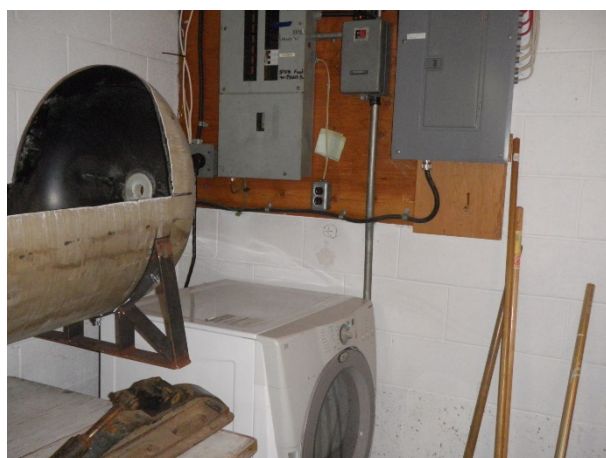
**Figure 72: Sample 2, main floor workshop north wall by panel, vermiculite insulation (trace actinolite asbestos)**

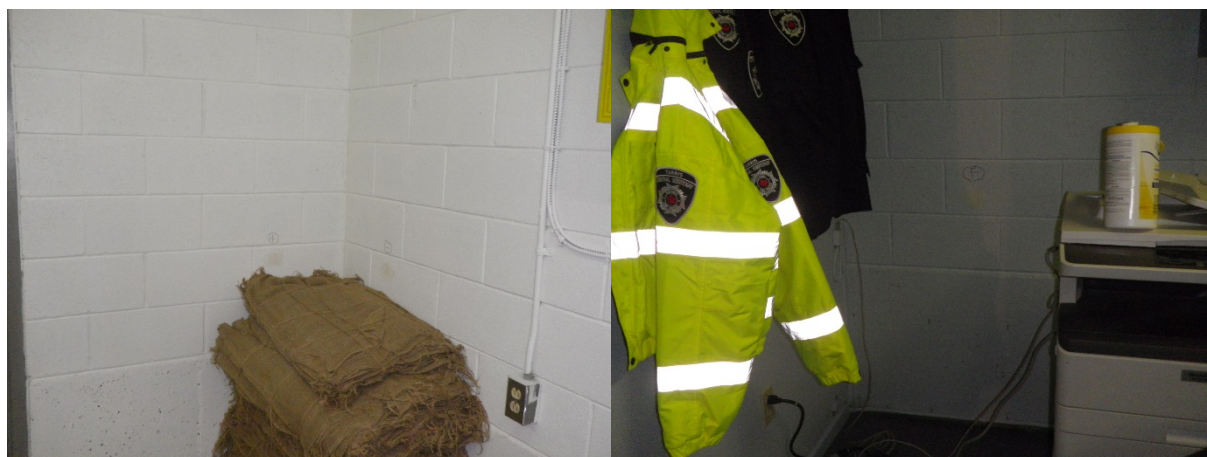
Figure 75: main bay west wall, north wall (+ve) office east wall (+ve)

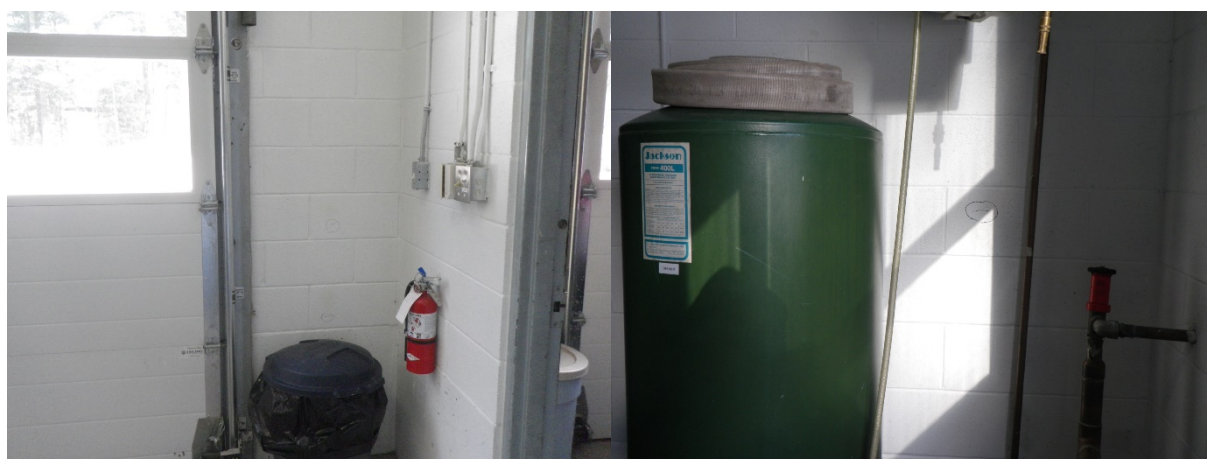
Figure 76: main bay east wall, concrete filled (assume (+ve)). North east main bay wall common with office was empty. Assume (+ve).

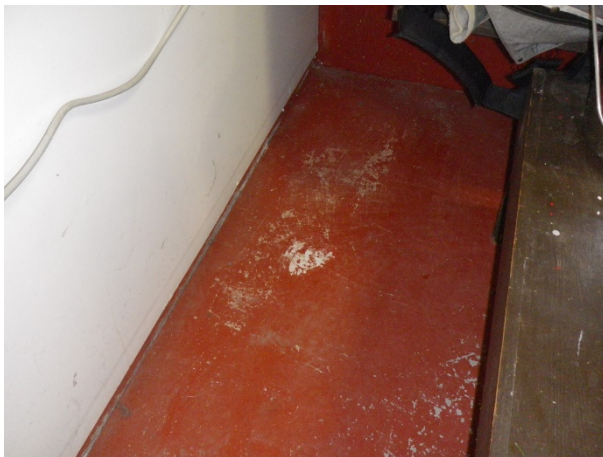
Figure 94: Sample B, main bay NW corner, red floor paint on concrete (5480 ppm)

The lead in paint interior locations were in good shape. Any scraping or repair to the sites where lead content exceeds 1000 ppm should be considered with manual scraper tools under low-moderate risk protocols. As the concentration increases one should consider increasing the controls to moderate risk protocols to minimize worker exposures to as low as reasonably achievable (ALARA) levels.

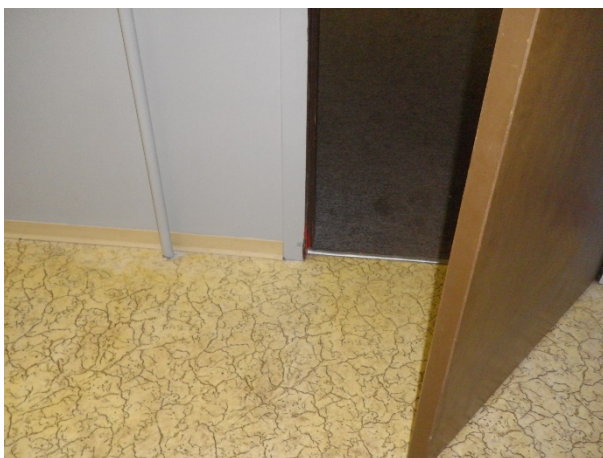
**Figure 98: Sample F, 2nd floor kitchen, north door trim, brown paint on metal trim (805ppm)**
