# Development Permit

DP2307E (Levinson)

**2205 Bealby Road, Rural Nelson, BC**

## **Riparian Assessment V 2.2**

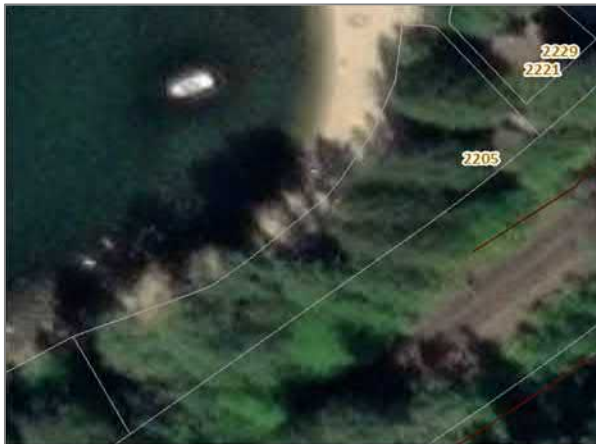
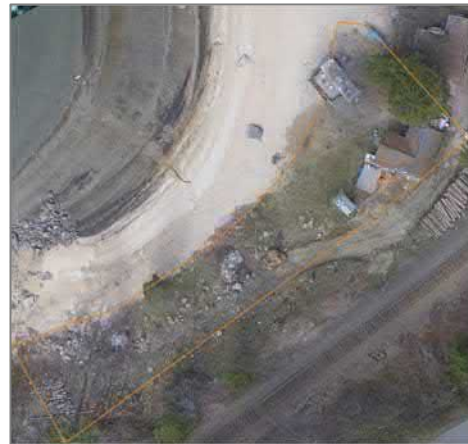
At the time of the site visit, >90 % of the native riparian vegetation had been impacted by tree falling (Photo 1 and Photo 2). Cleared trees included ~7 mature black cottonwood (*Populus trichocarpa*) trees, 3 mature Douglas maple (*Acer glabrum*) clusters, 2 mature lodgepole pine trees, 1 mature paper birch cluster, and ~12 mature Western redcedar trees (Photo 3 and Photo 4). A total of 25-30 trees were removed from the riparian assessment area with only three trees retained which included two Western redcedars and one lodgepole pine. Some regenerating cottonwood seedlings were also left along the foreshore.

Photo 1. Aerial view of property prior to clearing activities. Photo 2. Aerial view of property post clearing.

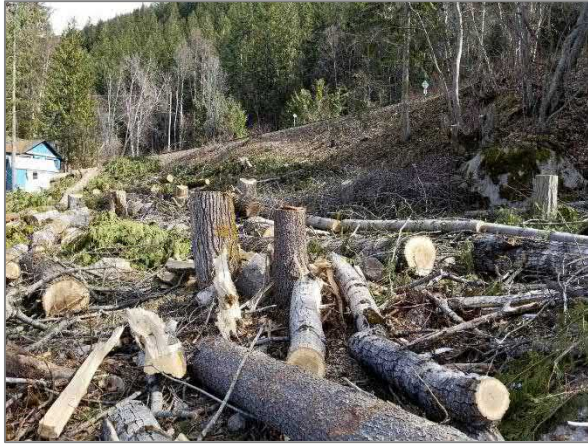
Photo 3. View of cleared trees looking east.

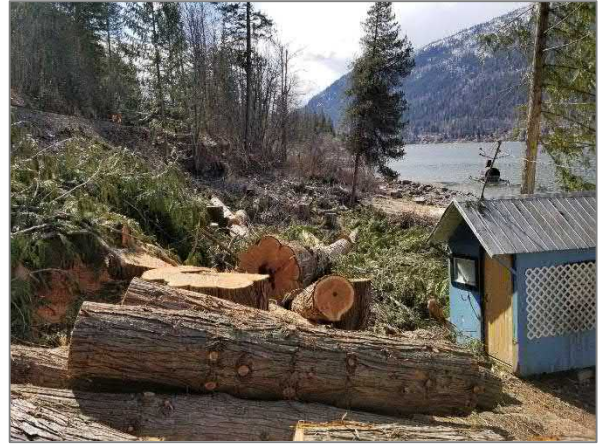
Photo 4. View of cleared trees looking west.

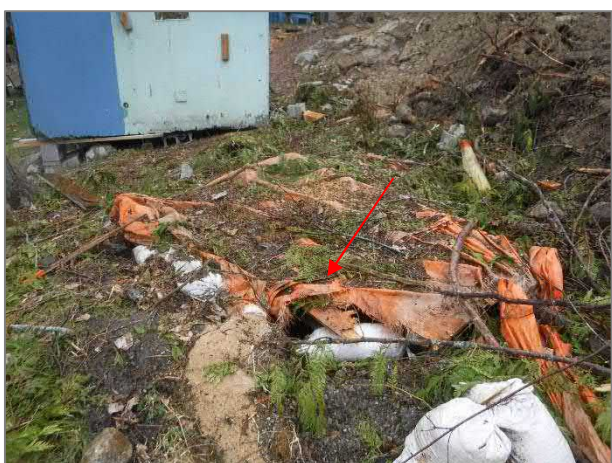
The wooden pumphouse located next to the cabin (footprint ~8 m<sup>2</sup>) has been constructed on cement blocks and is located ~9 m from the “natural boundary” (Photo 5 and Photo 7). The pumphouse draws water from an intake line installed into Kootenay Lake (Photo 6). A PVC pipe discharges water of an unknown origin to the lake beside the water intake (Photo 6).

Photo 5. View of Hall Spring (abandoned) southwest of pumphouse

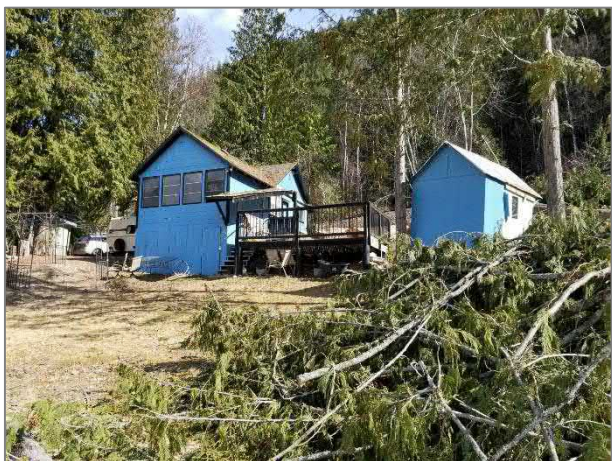
Photo 7. View of one-bedroom cabin, deck and pumphouse.

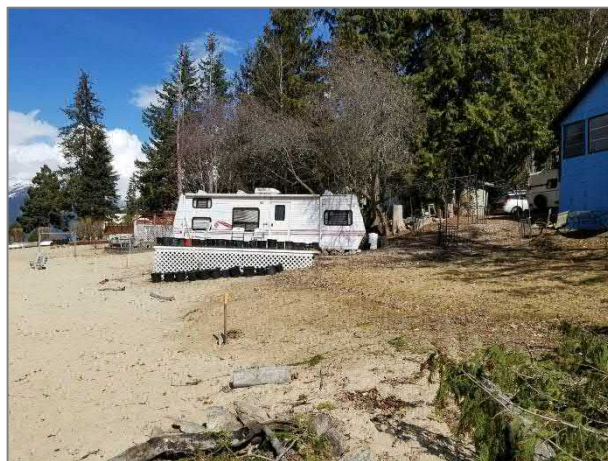
A travel trailer with wooden deck (footprint ~35 m<sup>2</sup>) was parked near the northern corner of the property (Photo 8). The travel trailer was used for storage and was located on the “natural boundary”.

Photo 8. View of travel trailer and deck.

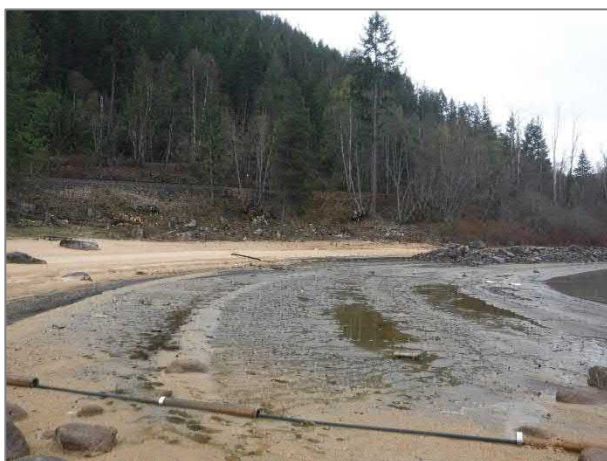
Photo 9. View of beach looking south from neighbouring property at low water.

The foreshore of the property is a sloped beach (~10 % gradient) with substrate consisting mostly of coarse sand with a few large boulders (Photo 9) and some fine gravel. Organic debris from the lake delineated the foreshore areas that were typically under water during high water levels. The in-water substrate was mostly saturated, fine silt and sand. Round boulders, cobbles, and some interspersed gravel pockets were present in the southwestern end of the property (Photo 10) and would be inundated at high water.

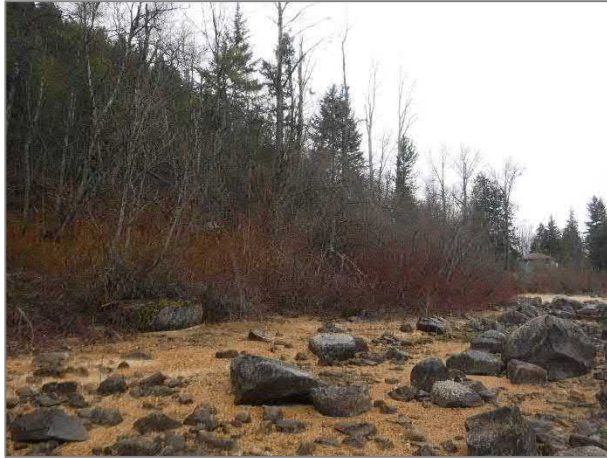
Photo 11. Cover habitat for fish at high water (bounders and emergent vegetation).

Fish habitat along this section of foreshore is juvenile rearing habitat and supports freshwater mussels. Cover habitat (boulders and emergent vegetation) for fish is present at the southwestern end of the property at high water (Photo 11). Multiple areas of groundwater emergence were also observed throughout the property, but suitable shore spawning salmonid habitat was not present due to a lack of suitable gravel substrate below late summer water levels. No known kokanee spawning has been reported in this area (KLP 2023).

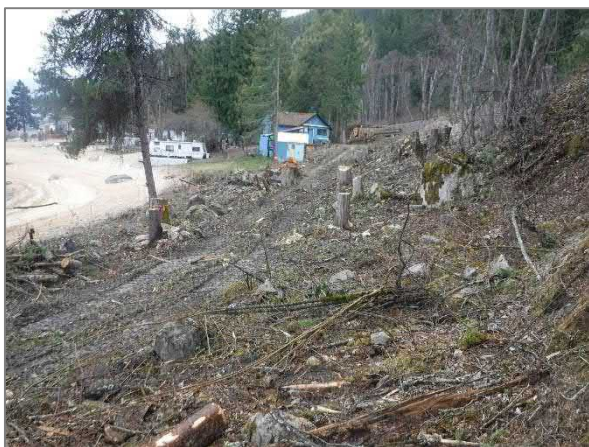
Photo 13. View of cut down riparian vegetation on property.

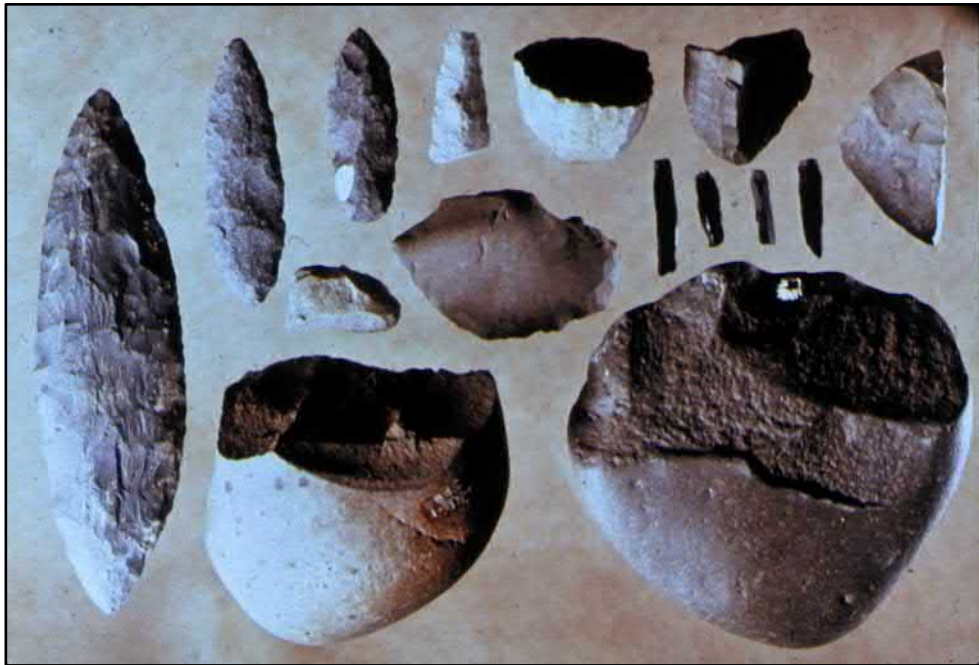
**Figure 1: Examples of lithic or stone artifacts found in the KBR**

A “lithic” is the result of a human intentionally striking or otherwise modifying a rock, usually in the pursuit of tool manufacture or repair. These tools or “flakes” look different from naturally occurring rocks in the same area and tend to be small, angular, or pointed rather than smooth, and can look like they have been broken in an intended way or appear to resemble arrow heads or spear points. Most often the material is of a certain type or grade that may appear different than others in the same area, and the pieces found may have semicircular rings or bumps, which occur when rock is hit in a very particular way (Figure 1).

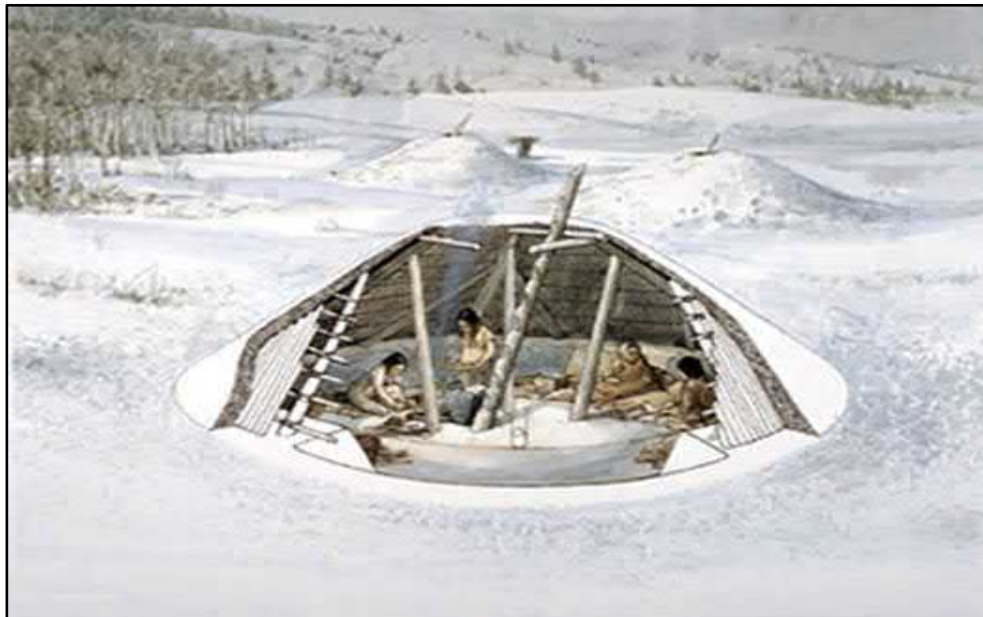
**Figure 2: Example of a Winter Pithouse**

Pithouses were occupied in both summer and winter (Figure 2). These sub-terranean dwellings are identified in all areas of the KBR, except in the area farther east of Kootenay Lake and to the BC-Alberta border and northward to around the Columbia Lake area and where tipi rings reflect a more nomadic occupation.

Pithouses are most often circular depressions that vary in depth and circumference, but almost always have a ridge or berm around the outer edge and charcoal or fire altered rock, representing a hearth, in the bottom. Tipi rings are circular outlines of transported rocks (Figure 3) that would have been used to weigh the structure and hide ends at the bottom.

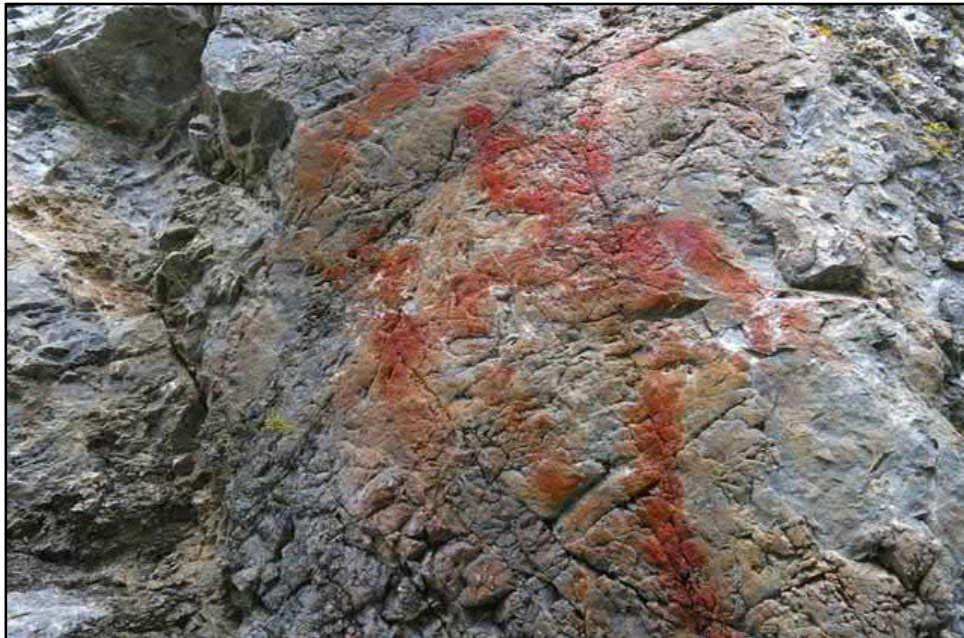
**Figure 4: Example of a Pictograph Found in the KBR**

“Rock art” refers to pictures or symbols that indicate a direction or geographic area. Petroglyphs are pictures made by cutting or hitting/pecking rock repeatedly, while pictographs are painted using a combination of ground red ochre mineral with a base such as egg white. Many of the rock art sites in the KBR are pictographs that are found on rock faces along waterways, but they can also be found elsewhere, indicating an area of cultural and spiritual significance. Referred to most often as panels, rock art can form a singular picture (Figure 4) or be part of a multi-image panel.

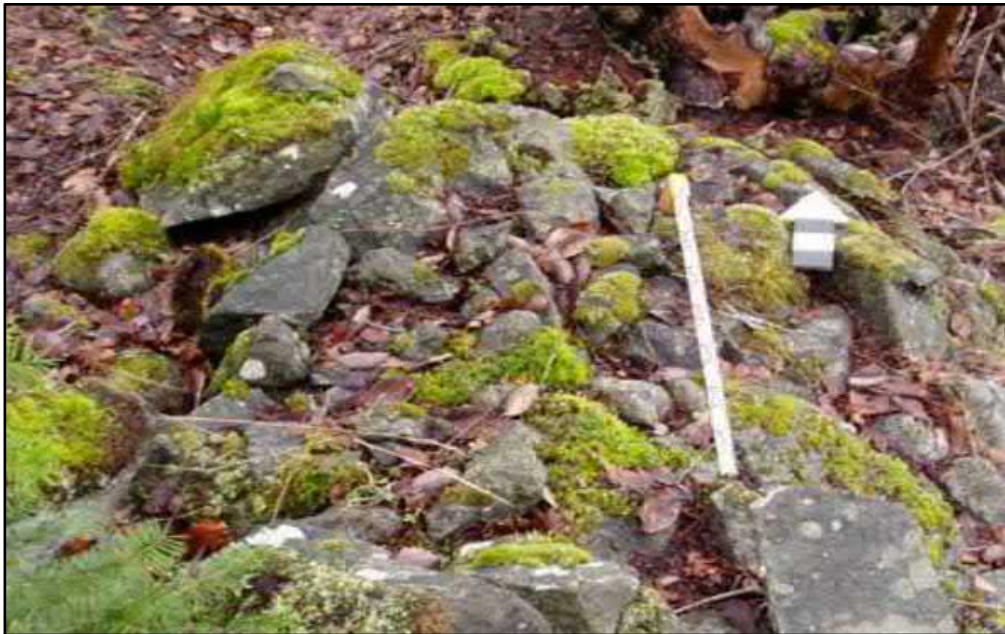
**Figure 5: Example of a Rock Cairn Burial**

Pre-modern burial sites are any places where the body (or bodies) of an expired human has been placed or otherwise left. Burials consists of the partial or intact remains of at least one individual but may also contain whole or part of multiple individuals. In the KBR the burial types that are most likely to be identified are subsurface burials where bodies are placed in a foetal position along or facing a water body – sometimes these are then covered with piles of rock or “cairns” placed on top (Figure 5), mounded earth burials, cave or rock shelter burials, or those found along the edge of talus slopes.
