# POST-WILDFIRE NATURAL HAZARDS RISK ANALYSIS ARGENTA CREEK WILDFIRE (N71058)

**Sitkum Project No. 24-1990**

**March 31, 2025**

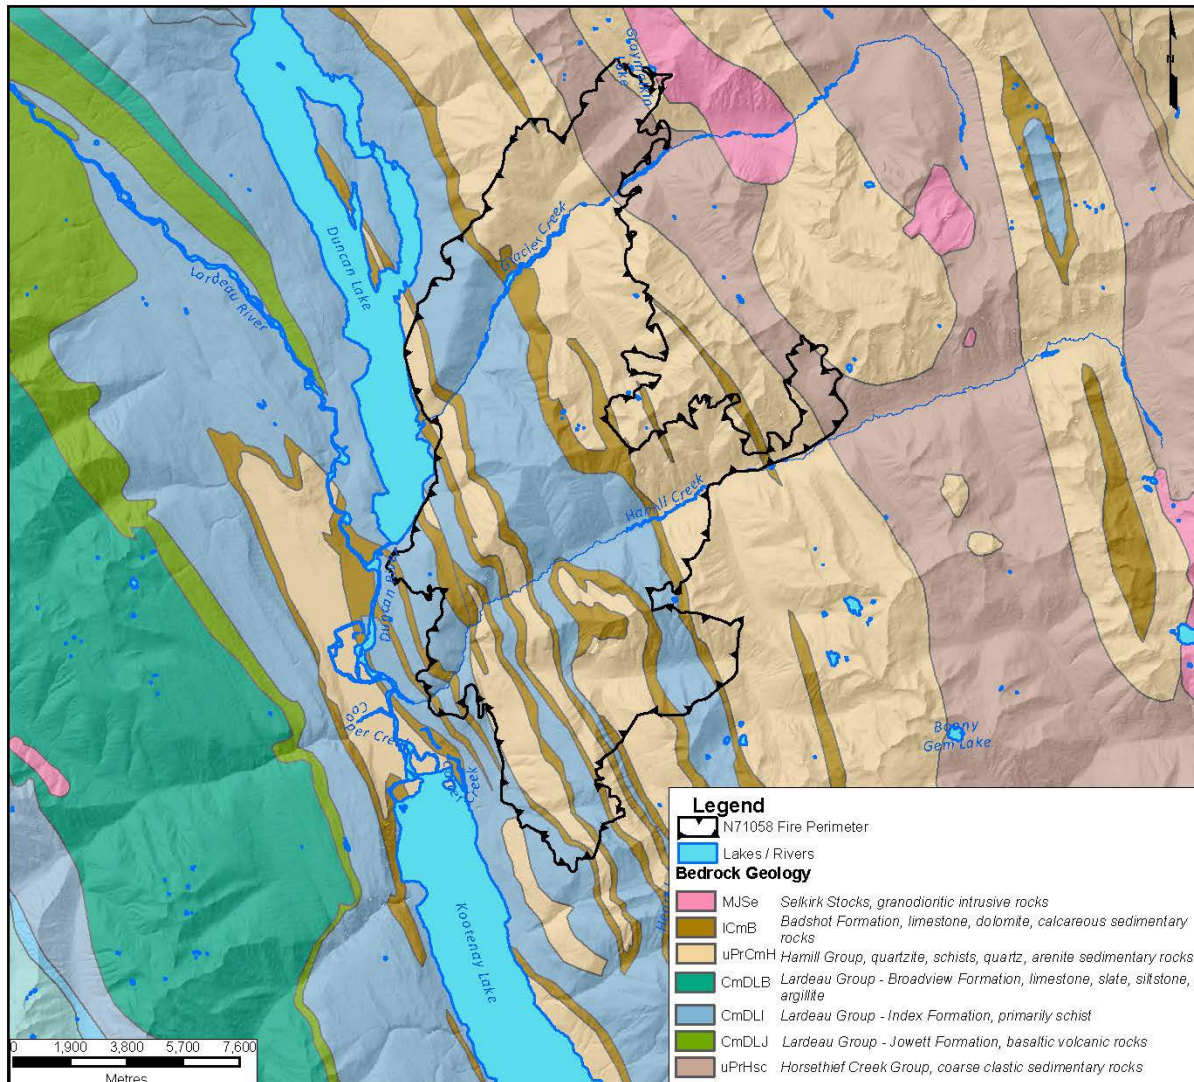
**Figure 6:** Argenta Creek Wildfire Bedrock Geology Map

The Badshot Formation within the study area has been classified as primary karst likelihood and high karst development intensity based on provincial reconnaissance karst potential mapping (Stokes 1999). This classification is based on regional geology mapping and the proportion of soluble bedrock. Within the fire perimeter north of Hamill Creek, the Badshot Formation consists primarily of dolomite with some interbedded crystalline limestone and phyllite. To the south of Hamill Creek, within the Badshot Formation, there is a greater presence of crystalline limestone (Fyles 1964). The high solubility of the limestone bedrock is responsible for the high karst potential within the Argenta Creek watershed, with evidence of tufa (a carbonate precipitate) observed in some seepage sites along the Argenta Creek gully indicating the emergence of groundwater from a calcium carbonate rich source.

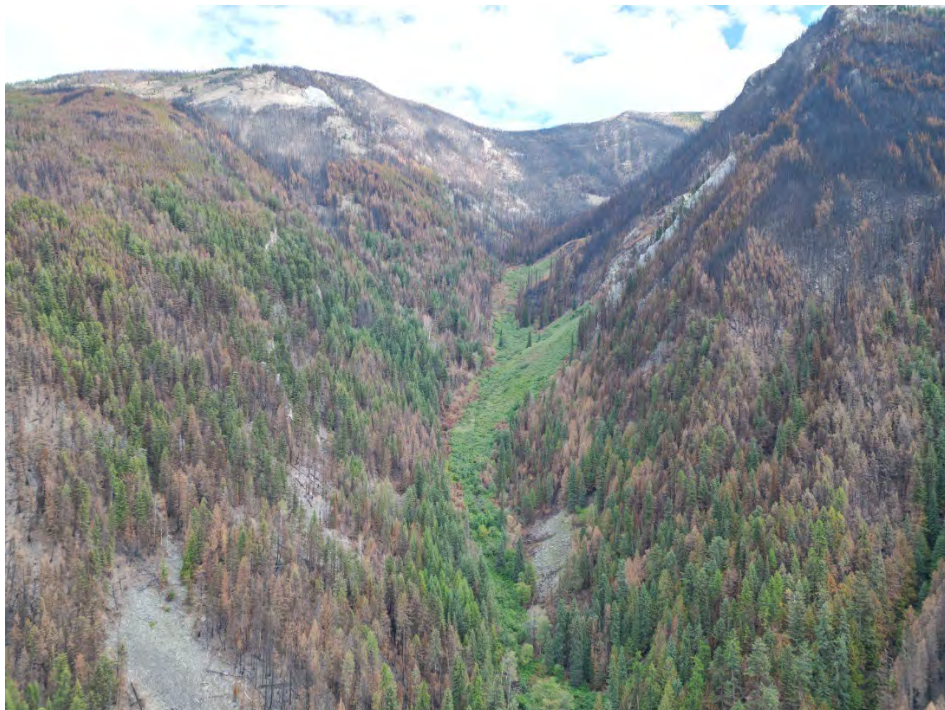
Argenta Creek is a steep, mountainous watershed with till and colluvial surficial materials as well as bedrock outcrops (Appendix A, Photo 2). The watershed has snow avalanches, rock fall, and debris flows as the primary hydrogeomorphic processes. Snow avalanches and rockfall are generally limited to the upper elevations of the watershed, but debris flows

**Photo 2:** Upper Argenta Creek watershed; drone photo Sept. 18, 2024.

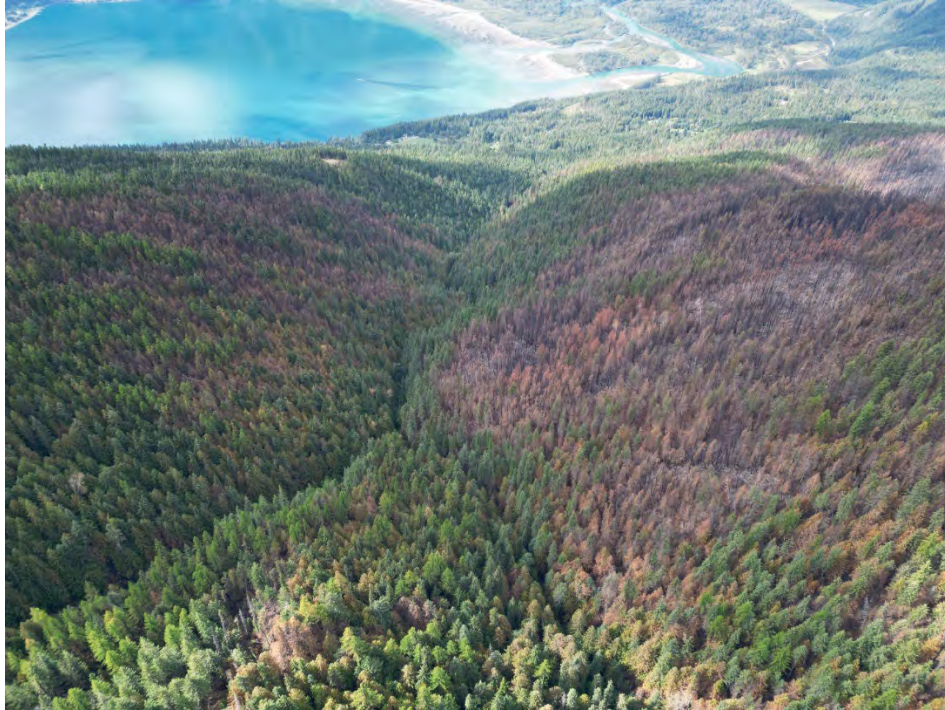
**Photo 4:** View downstream above the confluence of Argenta Creek and Argenta Creek South Fork (entering from left of photo). Drone photo Sept. 18, 2024.

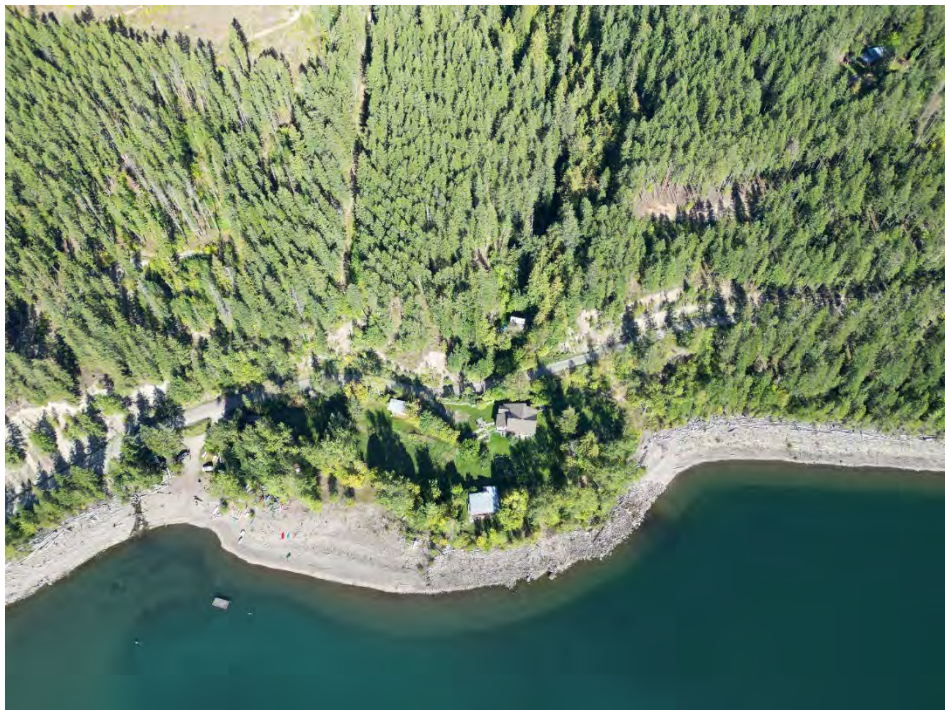
Argenta Creek has a small but well-defined fan at Kootenay Lake (Appendix A, Photo 5). The fan has an average slope gradient of 17% and is crossed by the Argenta Road near the apex (refer to Appendix F, Figure F5 for a creek profile). The fan surface has been modified by private land development, and there are residences on the fan. Argenta Creek has low confinement on the fan downslope of the lower Argenta Road crossing. Visual identification of the presence or absence debris flow history was not possible from Argenta Road crossing, but large boulders along the lakeshore at the edge of the fan indicate large bedload

**Photo 5:** Argenta Creek fan with private development; drone capture Sept. 16, 2024.

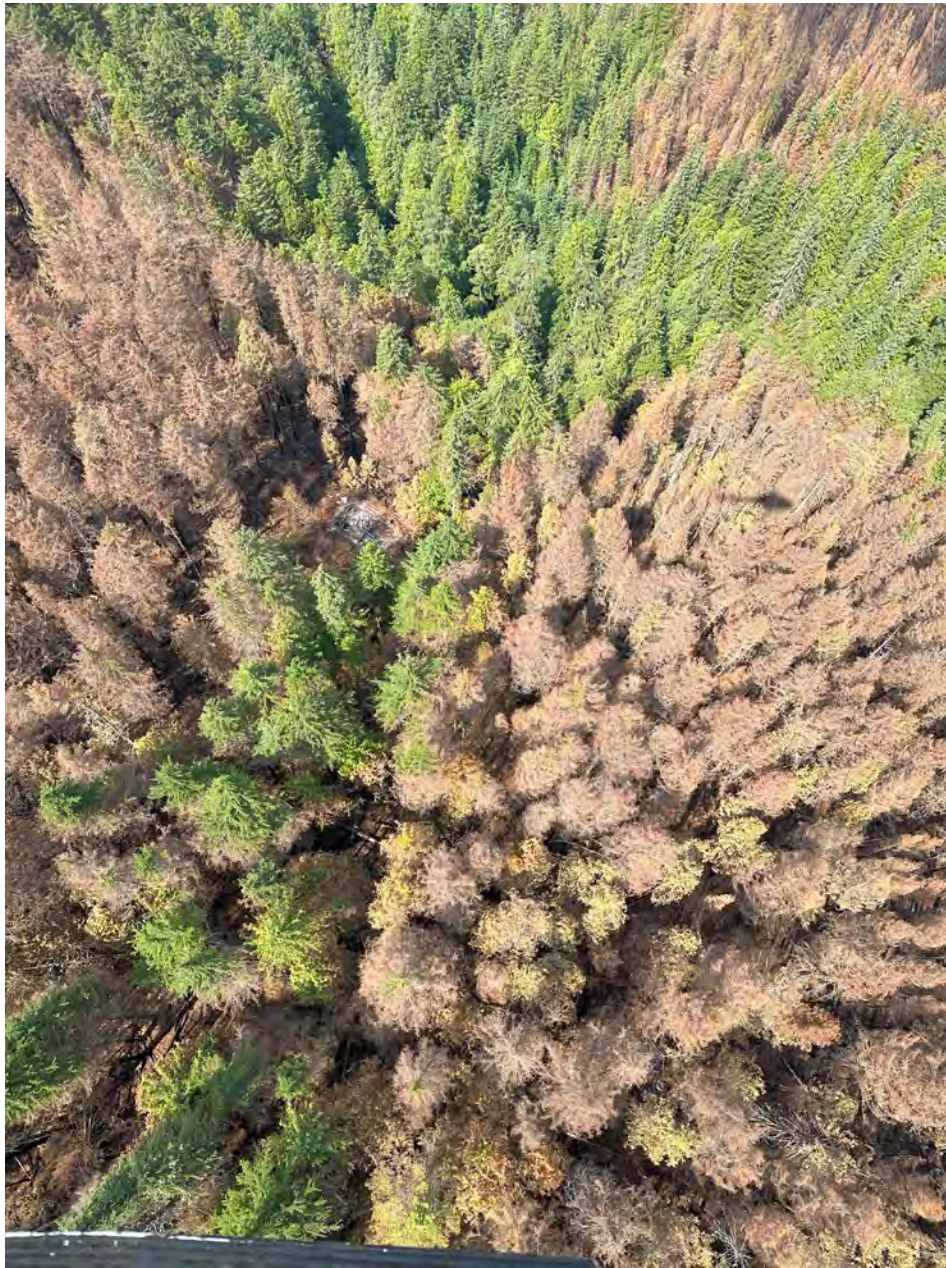
5. **Trapper's cabin** in Clint Creek (Appendix A, Photo 7).

**Photo 7:** Trapper's Cabin foundation, photo from helicopter overview flight Aug. 14, 2024.

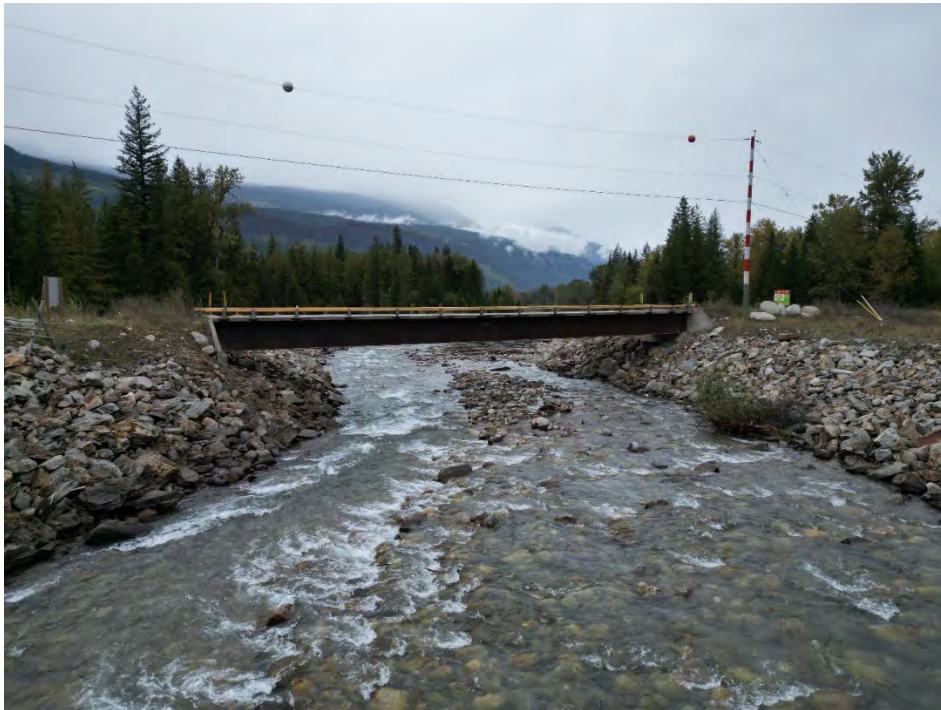
- a. The Duncan River FSR bridge (Appendix A, Photo 13) is the most likely part of road infrastructure on the fan to be impacted by flooding. The bridge currently has good clearance, and channel training has reduced vulnerability of the bridge since repairs after the 2013 flood event.

**Photo 13:** Hamill Creek bridge on Duncan River FSR looking downstream; drone photo October 1, 2024.
