### TARRY'S FIRE HALL WINDOW REPLACEMENT PROJECT PRJ24054

#### ADDENDUM NO. 1

# 24017-TARRYS FIRE HALL

ASBESTOS, LEAD AND OTHER IDENTIFIED HAZARDS

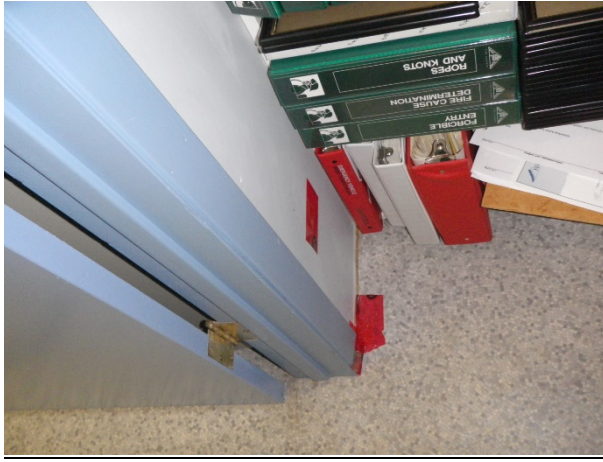
Figure 1: Sample 1, sheet vinyl flooring (grey pebble) 2nd floor training room in A/V room NE corner

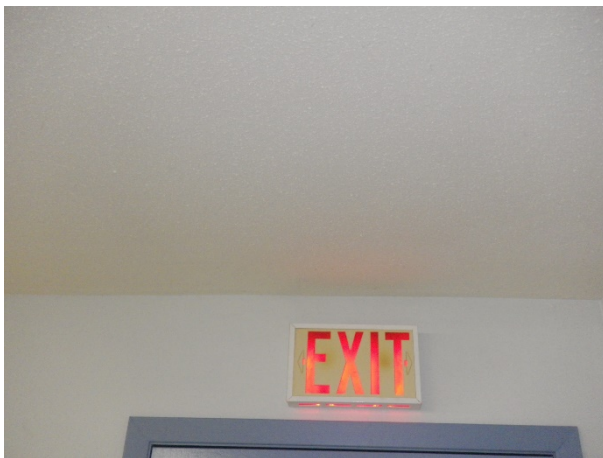
Figure 2: Sample 4; 2nd floor training room above south entry door, texture coat

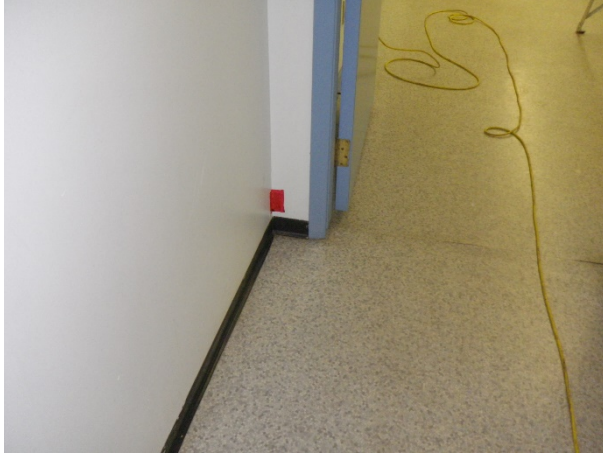
Figure 3: Sample 5; 2nd floor west hallway NW corner, drywall joint compound

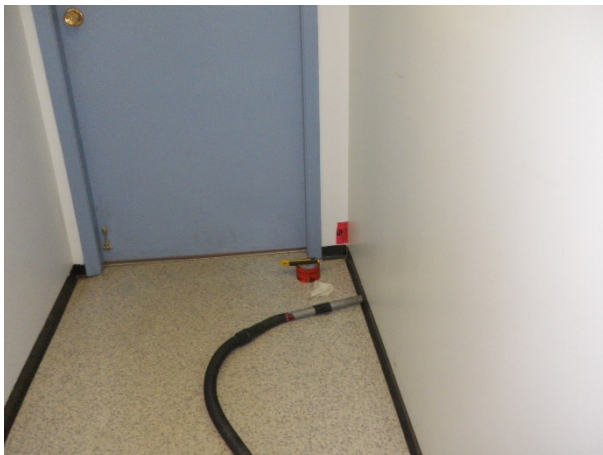
Figure 4: Sample 6; 2nd floor west hallway, SW corner, drywall joint compound

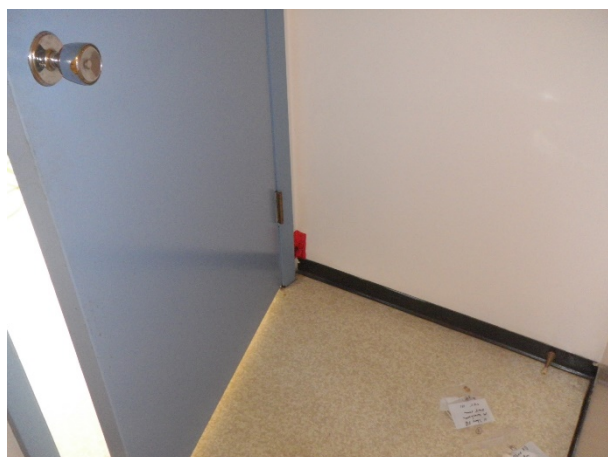
Figure 8: Sample 10; 2nd floor men's washroom SW corner, drywall joint compound

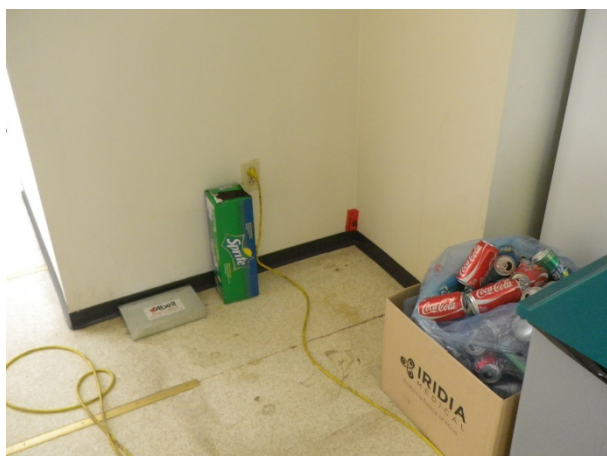
**Figure 10: Sample 12, 2nd floor recreation room, SE corner, drywall joint compound**

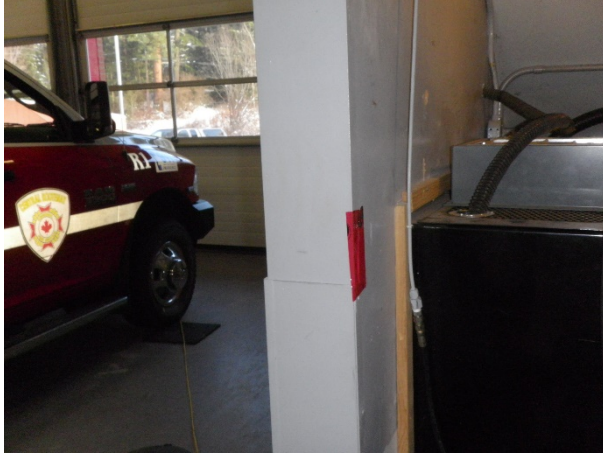
Figure 12: Sample 14, main floor south wall corner by compressor, drywall joint compound

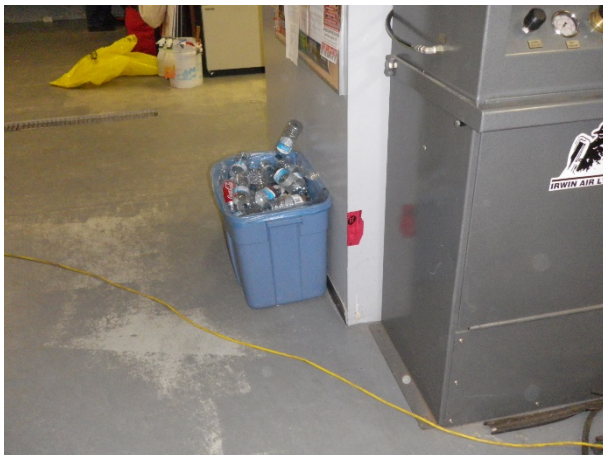
Figure 13: Sample 15, main floor, middle corner at tank fill, drywall joint compound

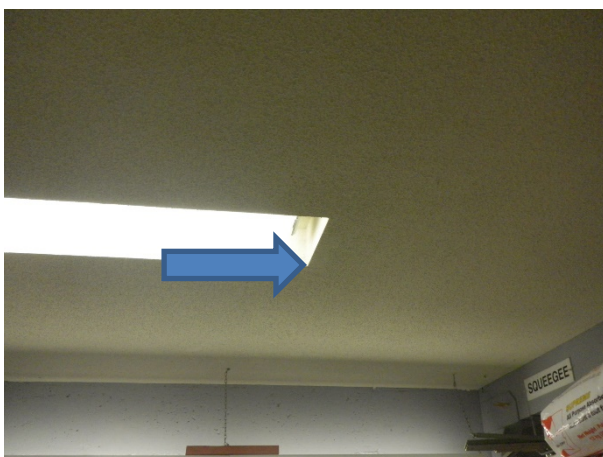
Figure 14: Sample 16, main floor, wet side ceiling at west light fixture, texture coat

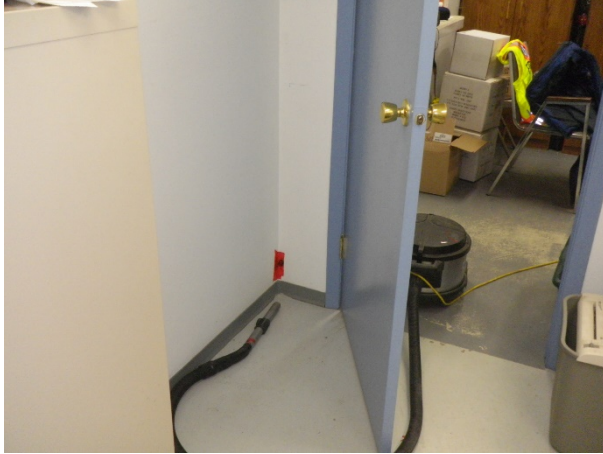
Figure 15: Sample 17, main floor computer room NW corner, drywall joint compound

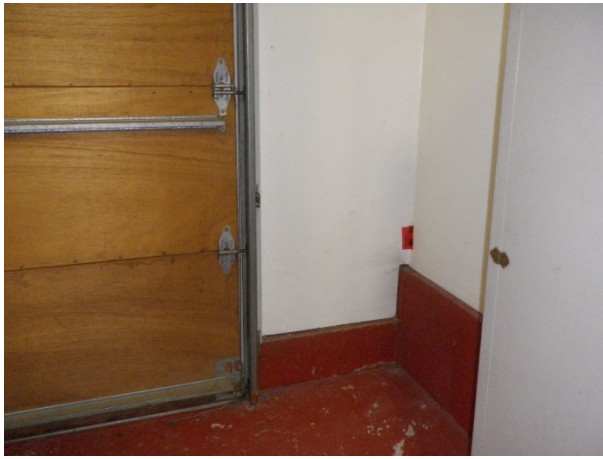
Figure 16: Sample 1, main floor main bay, SE corner, drywall joint compound

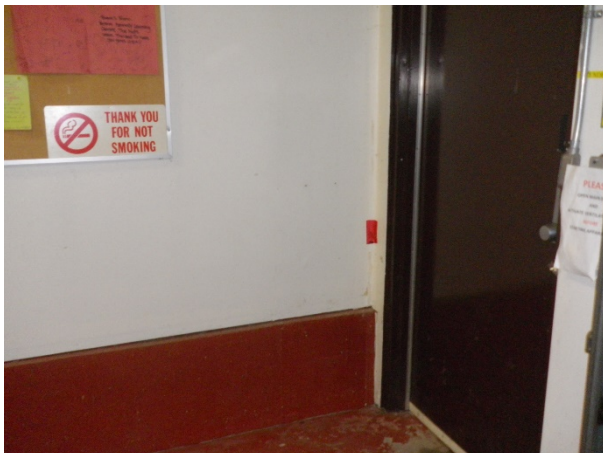
Figure 17: Sample 2, main floor main bay NE corner, drywall joint compound

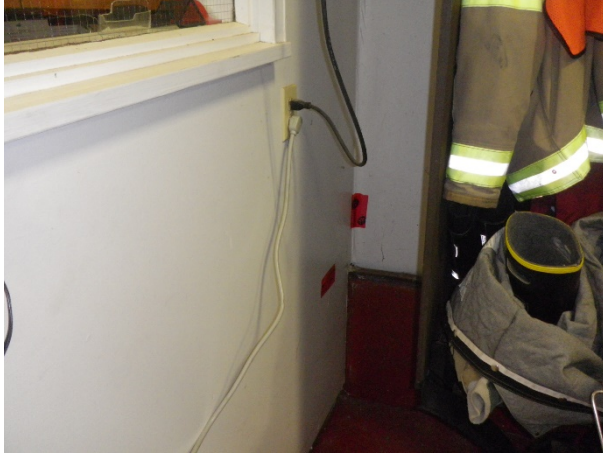
Figure 18: Sample 3, main floor main bay, NW corner, drywall joint compound

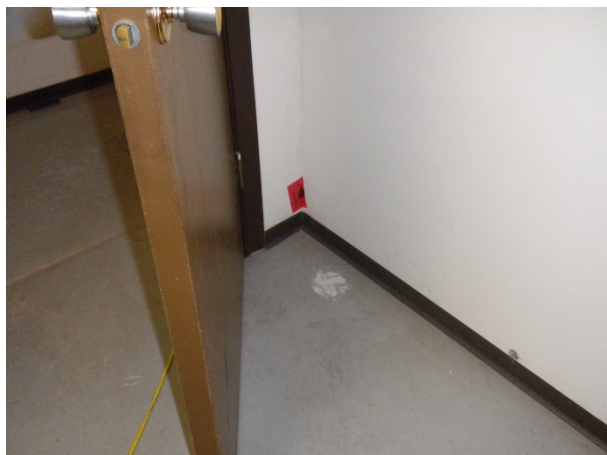
Figure 21: Sample 6, main floor men's washroom NE corner, drywall joint compound

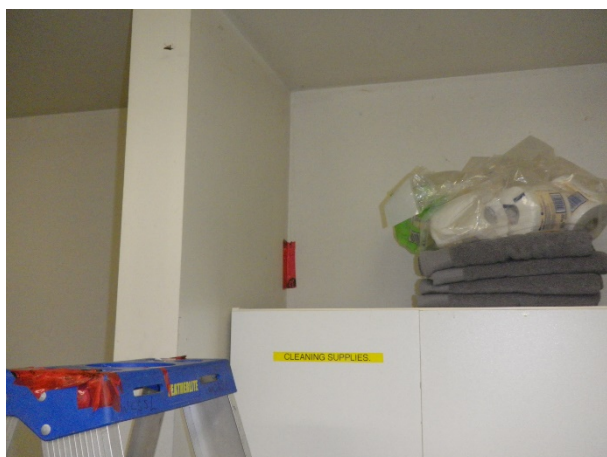
Figure 22: Sample 7, main floor men's washroom, south wall, drywall joint compound

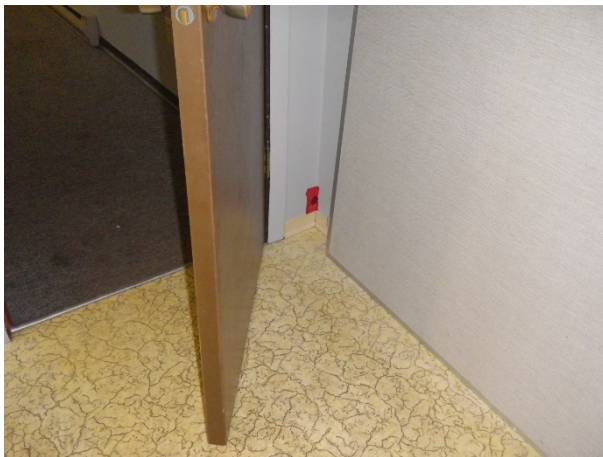
Figure 25: Sample 11, 2nd floor, kitchen NE corner, drywall joint compound

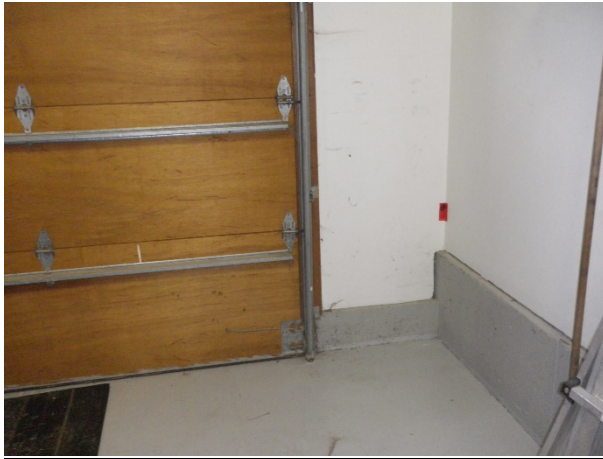
Figure 26: Sample 1; main bay NE corner, drywall joint compound

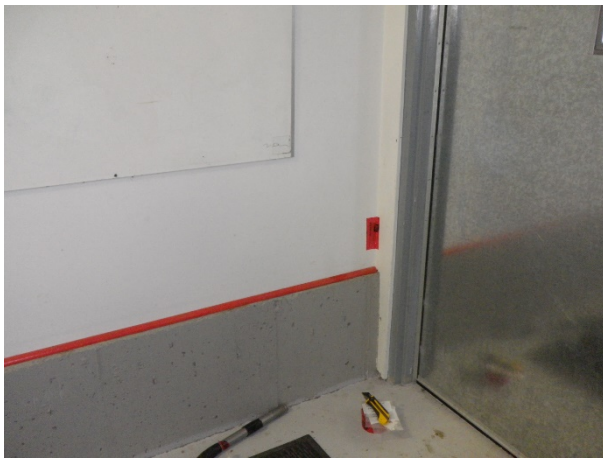
Figure 27: Sample 2 main floor, main bay NW corner, drywall joint compound

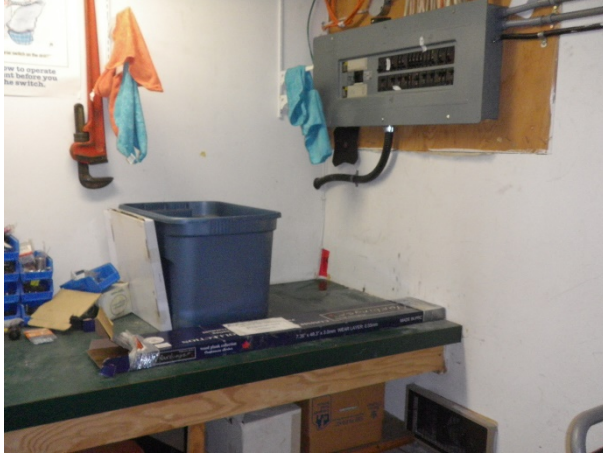
Figure 29: Sample 4, main floor SE storage room, drywall joint compound

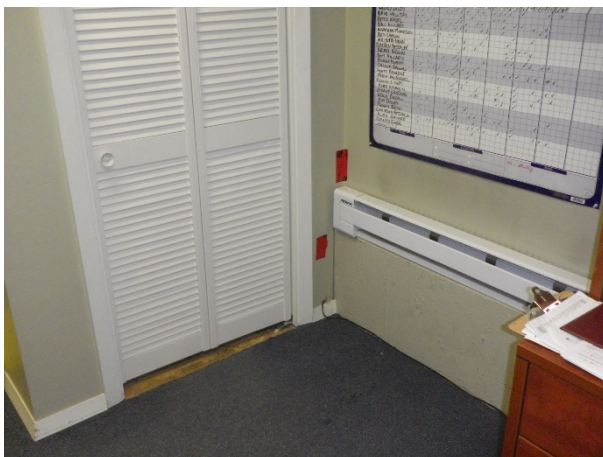
Figure 31: Sample 6, main floor office SW corner, drywall joint compound

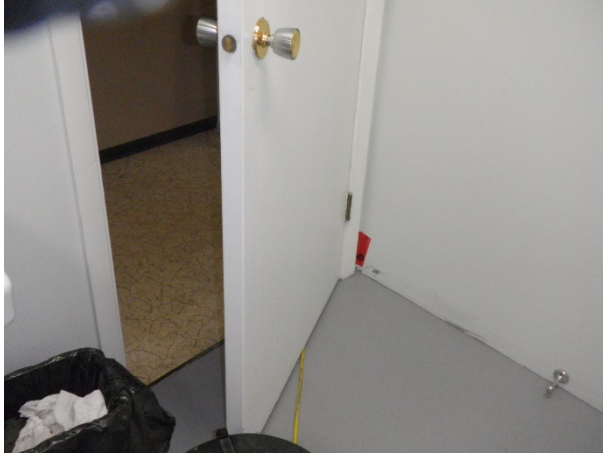
Figure 32: Sample 7, main floor men's washroom, NW corner, drywall joint compound

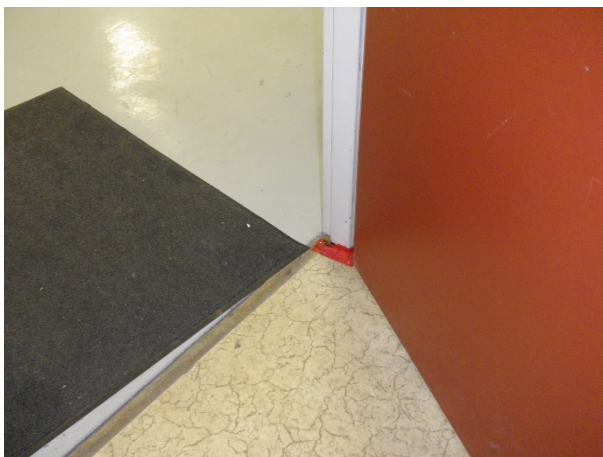
Figure 34: Sample 9, main floor hallway by north door, sheet vinyl flooring

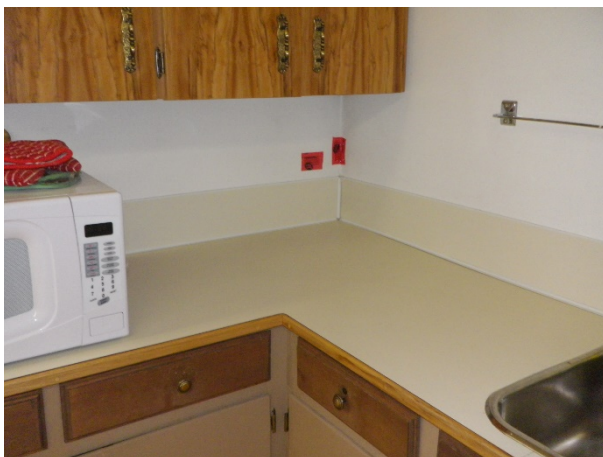
Figure 37: Sample 12, 2nd floor kitchen SE corner, drywall joint compound

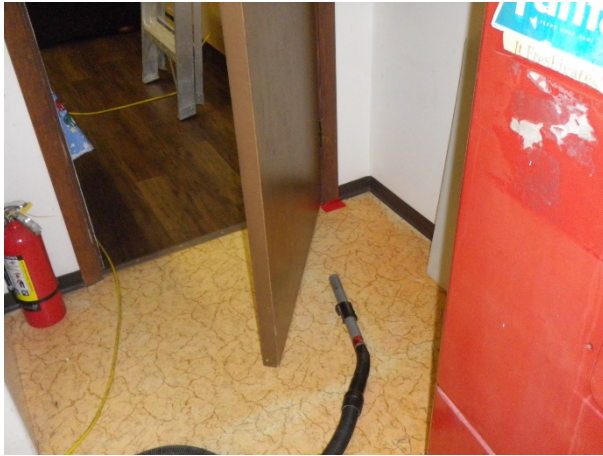
Figure 38: Sample 13, 2nd floor, kitchen, NW corner, drywall joint compound

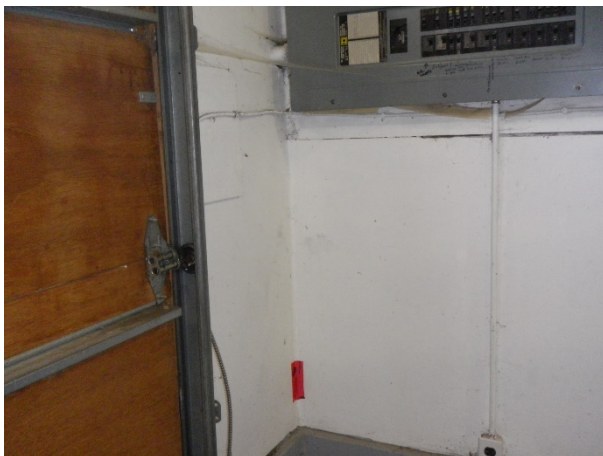
Figure 40: Sample 1, main bay SE corner, drywall joint compound

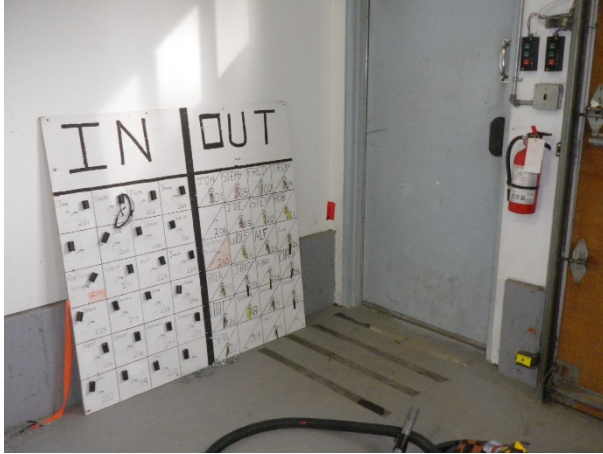
Figure 41: Sample 2 main floor main bay NE corner, drywall joint compound

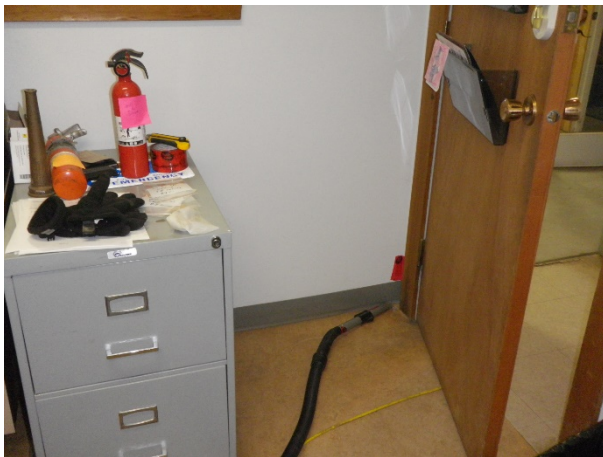
Figure 42: Sample 3, main floor office, SE corner, drywall joint compound

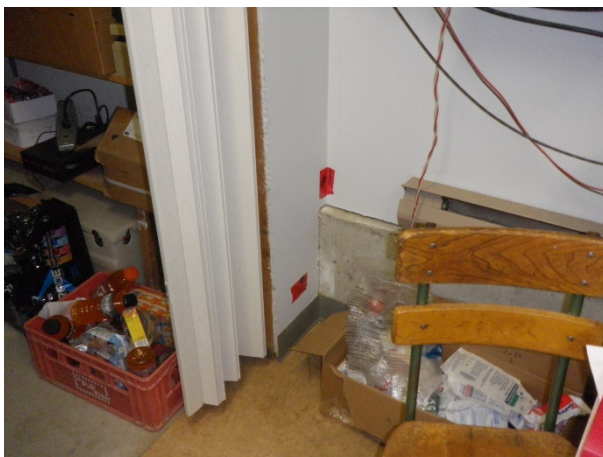
Figure 43: Sample 4, main floor office, NW corner, drywall joint compound

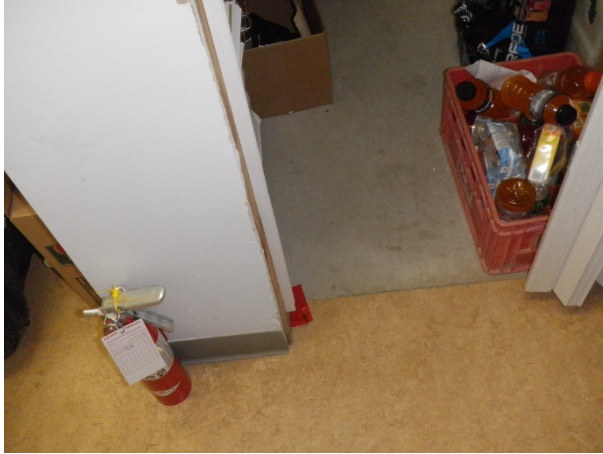
Figure 44: Sample 5, main floor office, NW corner, sheet vinyl flooring

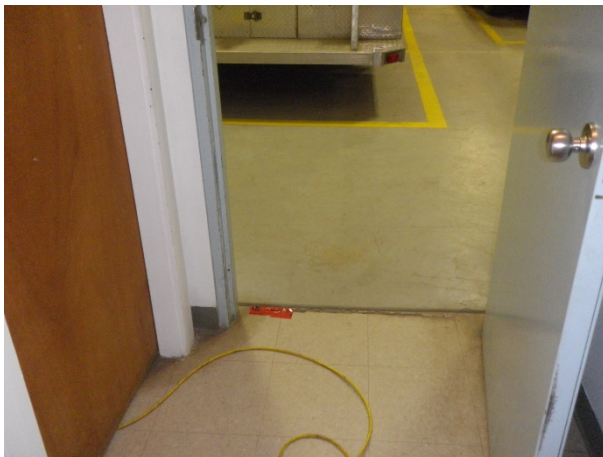
Figure 45: Sample 6, main floor hallway by east entry, vinyl floor tile

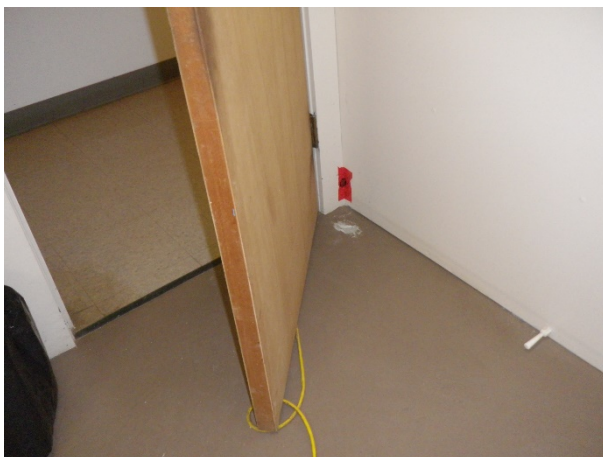
Figure 46: Sample 7, main floor, men's washroom, NE corner, drywall joint compound

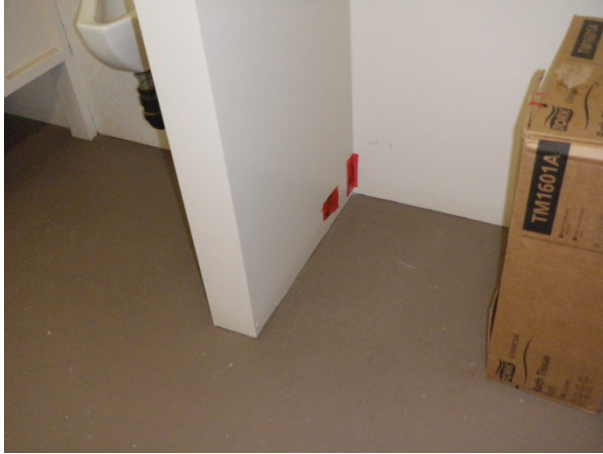
Figure 47: Sample 8, main floor, men's washroom south wall, drywall joint compound

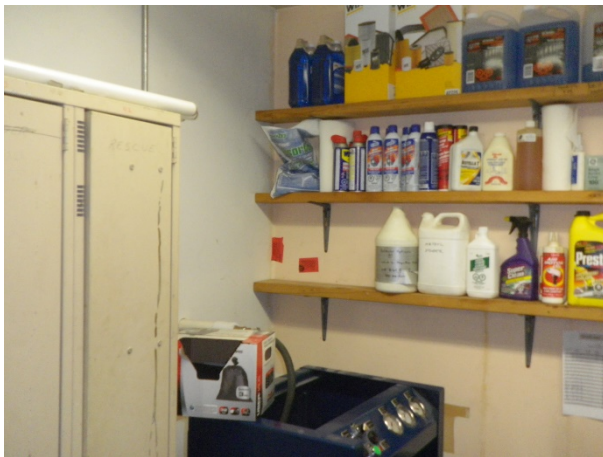
Figure 48: Sample 9, main floor work shop, SW corner, drywall joint compound

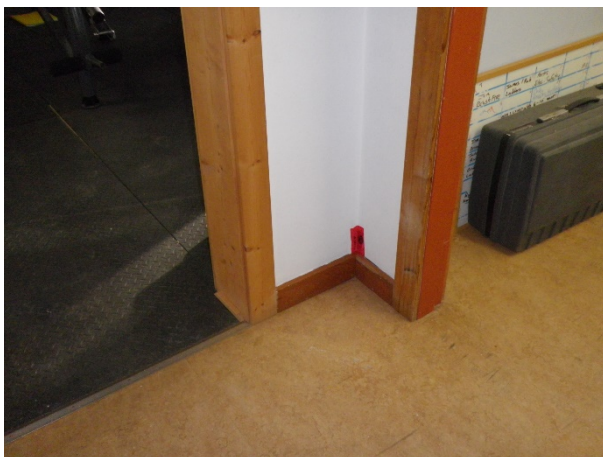
Figure 49: Sample 10, 2nd floor training room, SE corner, drywall joint compound

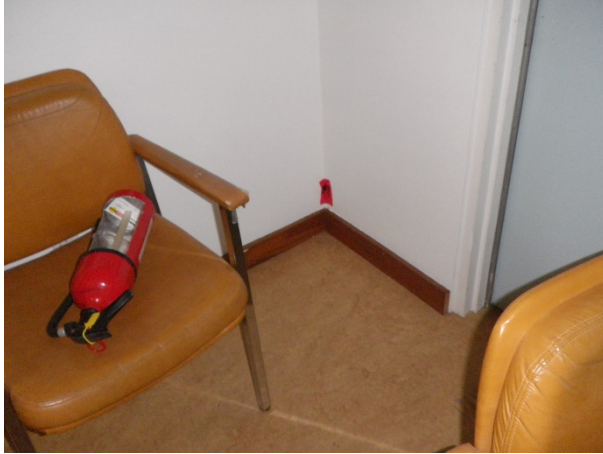
Figure 50: Sample 11, 2nd floor training room, SE corner, drywall joint compound

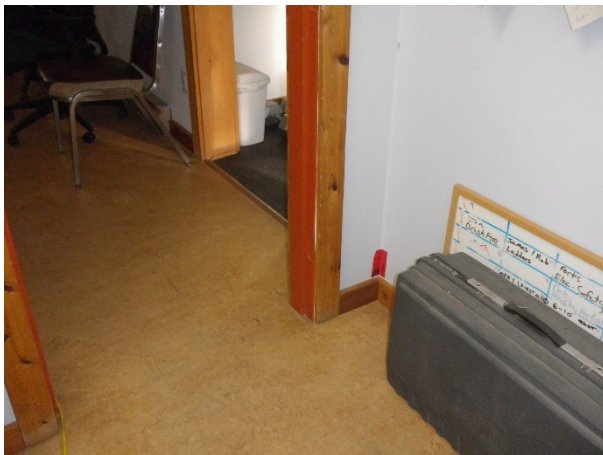
Figure 51: Sample 12, 2nd floor kitchen, NE corner, drywall joint compound

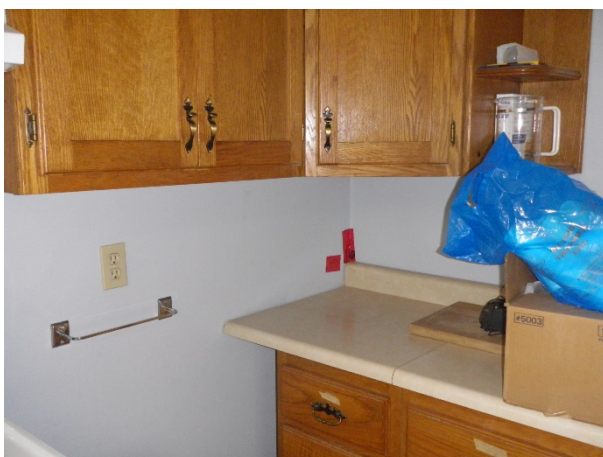
Figure 52: Sample 13, 2nd floor kitchen, SW corner, drywall joint compound

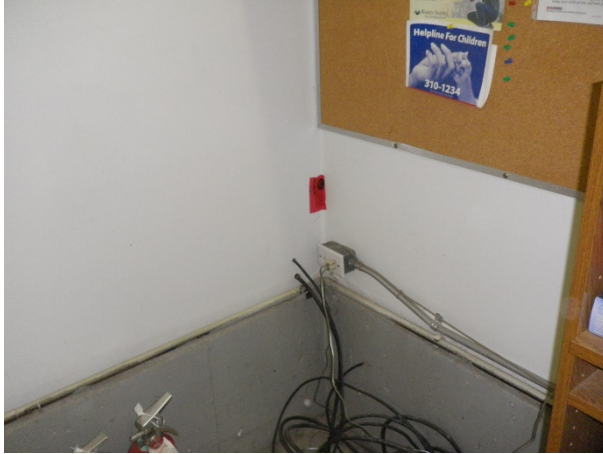
Figure 53: Sample 14, ambulance bay, NW corner, drywall joint compound

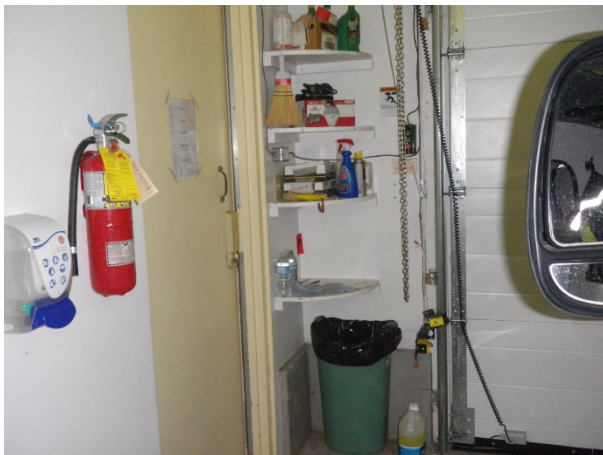
Figure 54: Sample 15, ambulance bay, NE corner, drywall joint compound

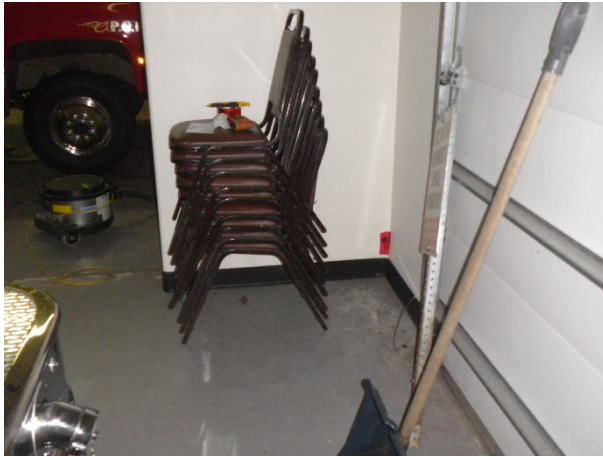
Figure 56: Sample 1, main floor main bay, NE corner, drywall joint compound

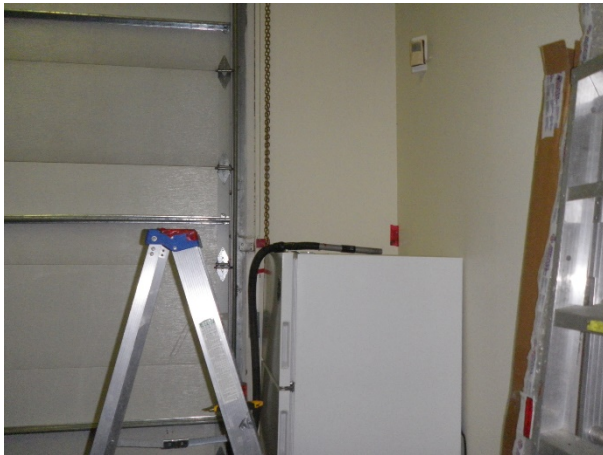
Figure 57: Sample 2, main floor main bay SE corner, drywall joint compound

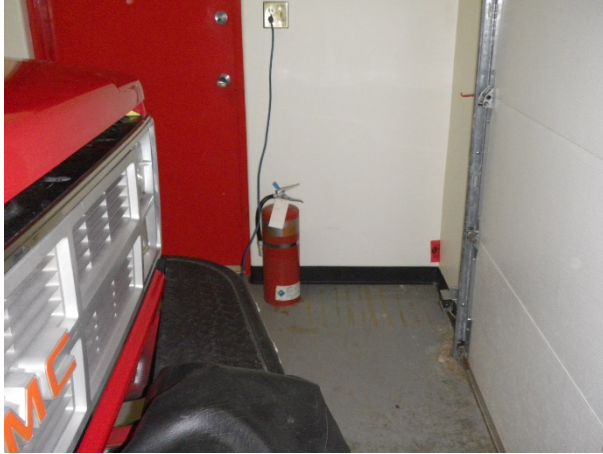
Figure 59: Sample 4, main floor, small bay NE corner, drywall joint compound

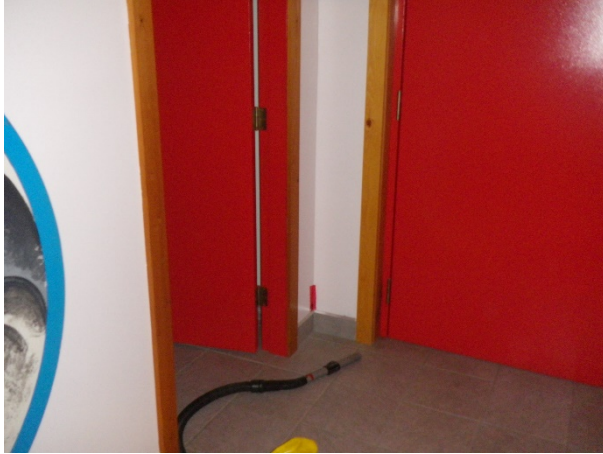
Figure 62: Sample 7, main floor hallway NW corner, drywall joint compound

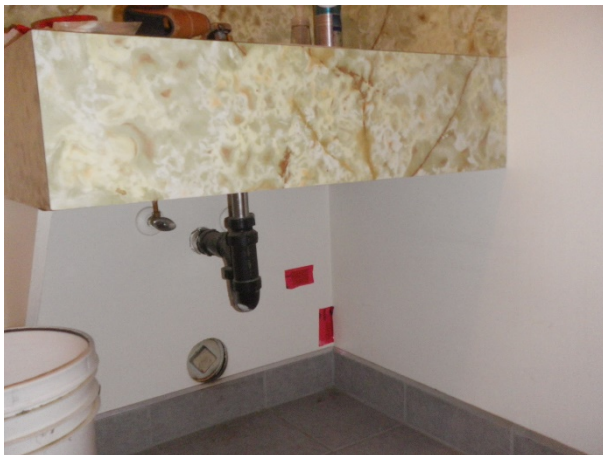
Figure 63: Sample 8, main floor men's washroom, NE corner, drywall joint compound

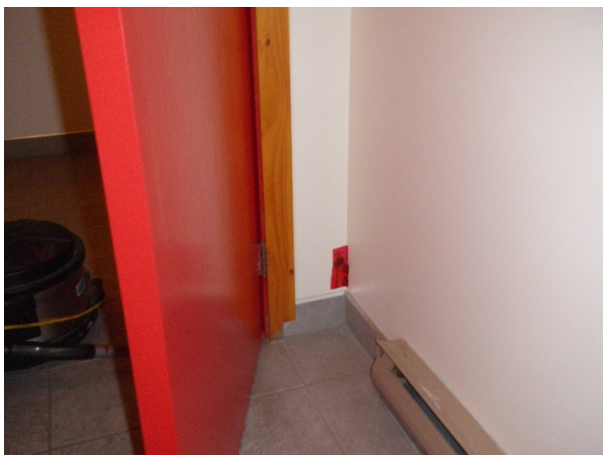
Figure 64: Sample 9, main floor men's washroom, SE corner, drywall joint compound

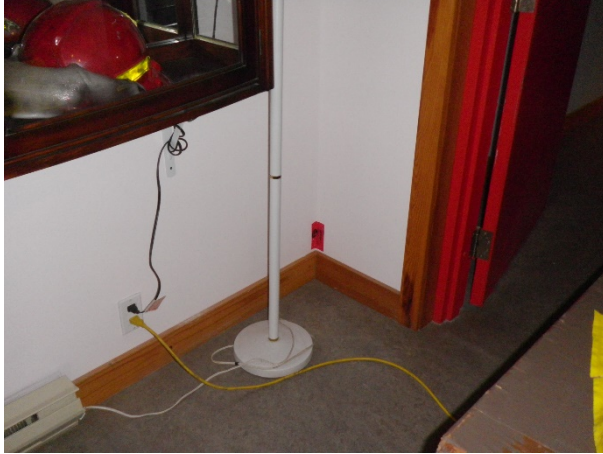
Figure 65: Sample 10, 2nd floor, recreation room, NE corner drywall joint compound

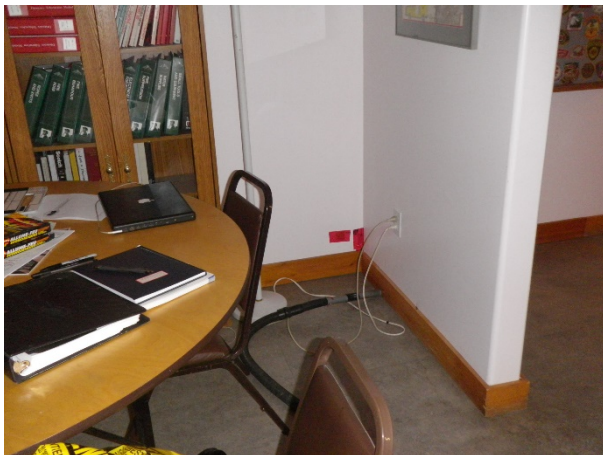
Figure 66: Sample 11, 2nd floor, recreation room, SE corner, drywall joint compound

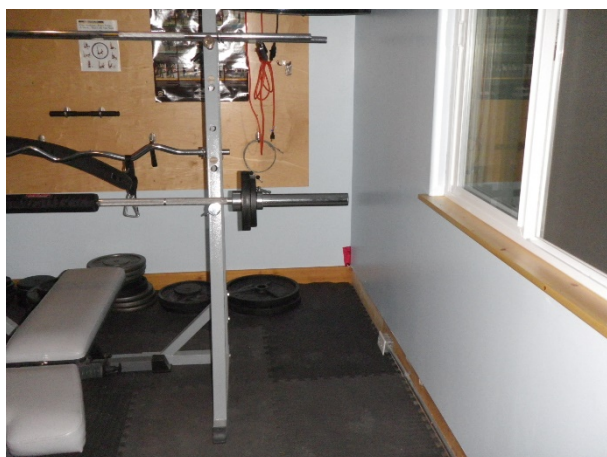
Figure 69: Sample 14, 2nd floor exercise room, SE corner drywall joint compound

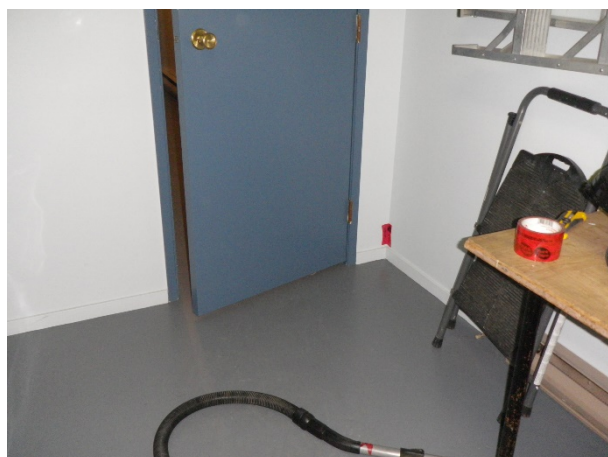
Figure 74: Sample 4, main floor workshop, SE corner drywall joint compound

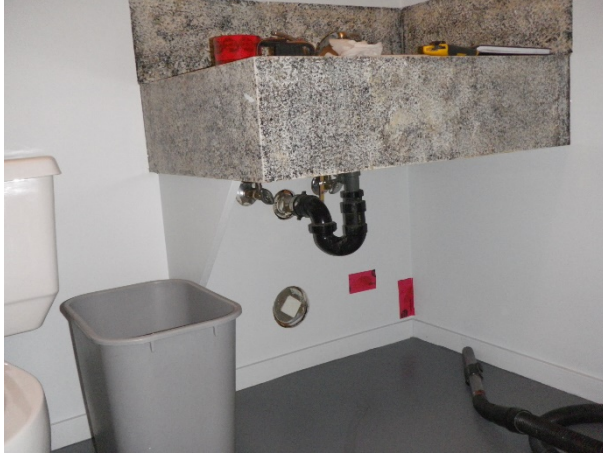
Figure 77: Sample 5, main floor south washroom, NE corner drywall joint compound

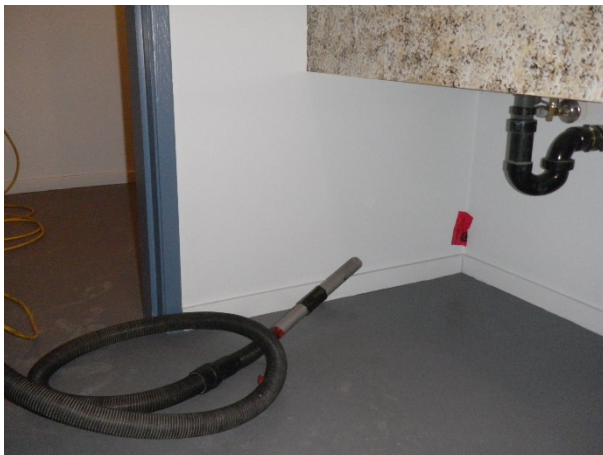
Figure 78: Sample 6, main floor north washroom SE corner drywall joint compound

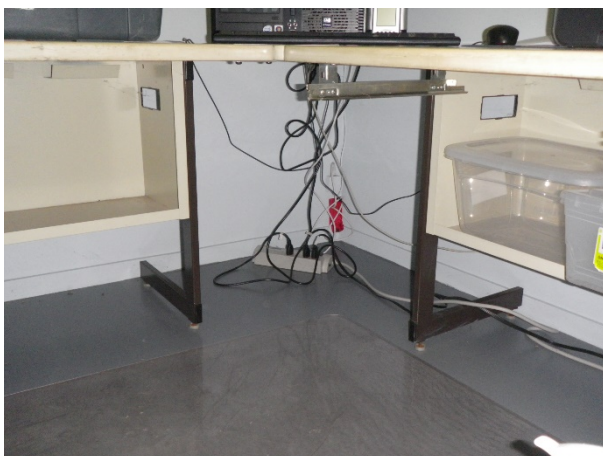
Figure 79: Sample 7, main floor office NW corner drywall joint compound

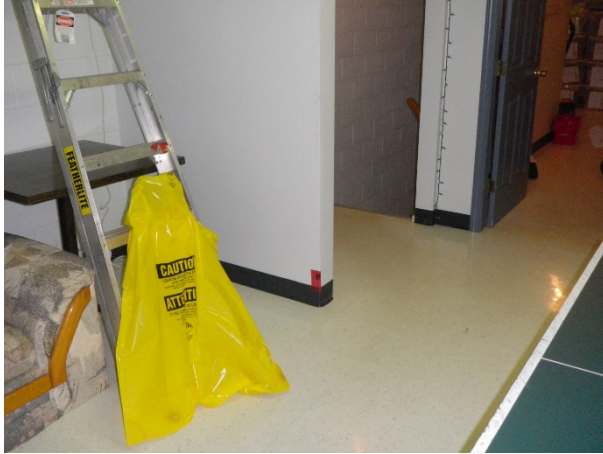
Figure 80: Sample 8, 2nd floor family room entry corner, drywall joint compound

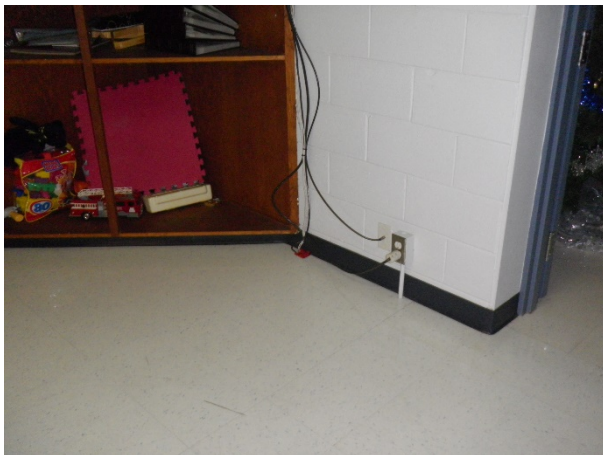
Figure 81: Sample 9, 2nd floor family room, NW corner vinyl floor tile

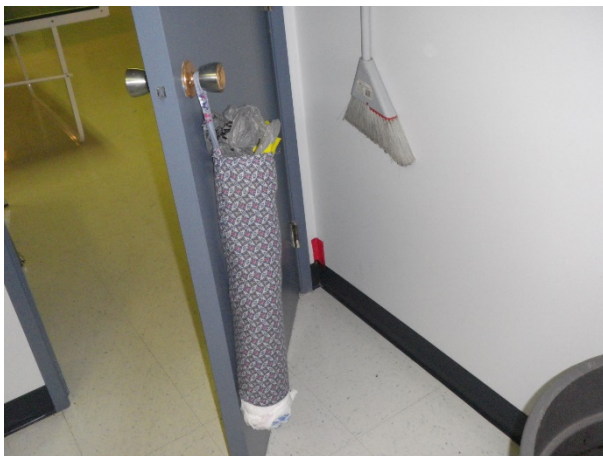
Figure 82: Sample 10, 2nd floor kitchen, NE corner drywall joint compound

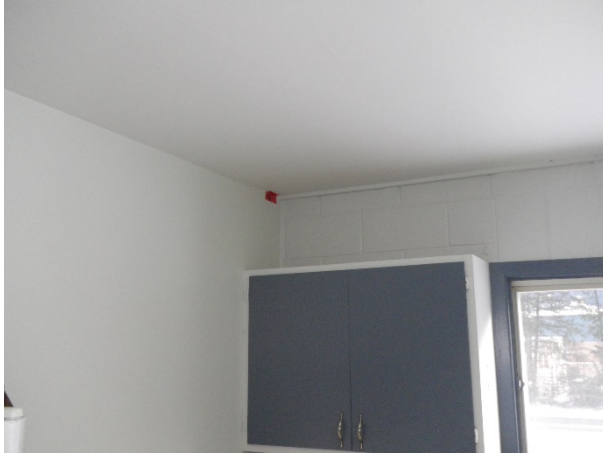
Figure 83: Sample 11, 2nd floor kitchen, NE corner drywall joint compound

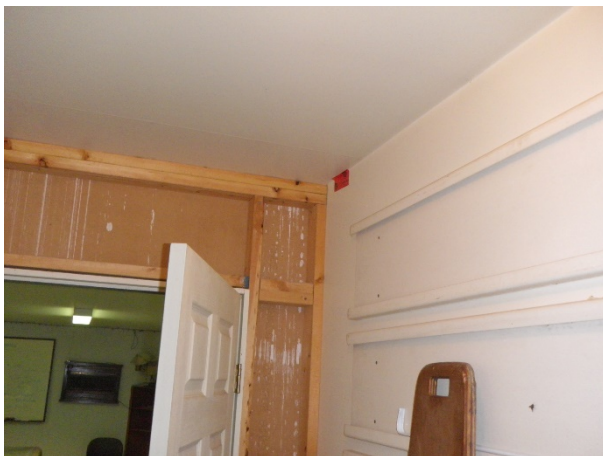
Figure 85: Sample 13, 2nd floor storage room, NW corner at ceiling drywall joint compound

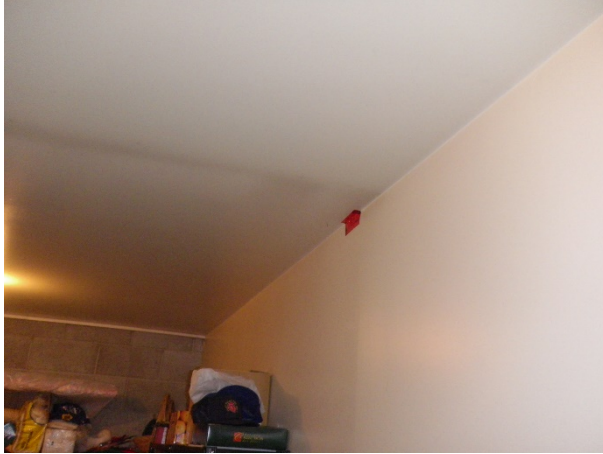
Figure 86: Sample 14, 2nd floor storage room, middle south wall at ceiling, drywall joint compound

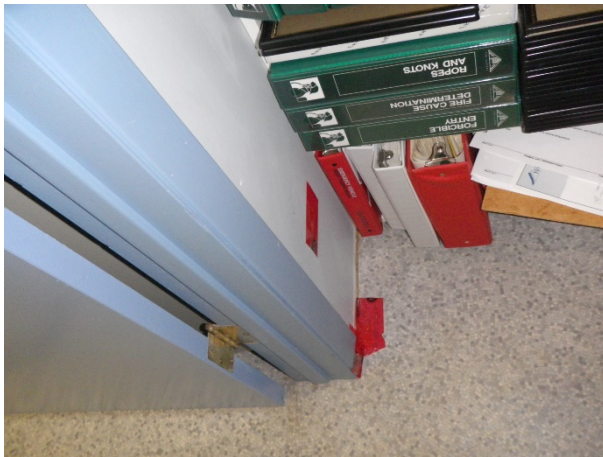
Figure 87: Sample A, 2nd floor training room, A/V room N wall light blue wall paint

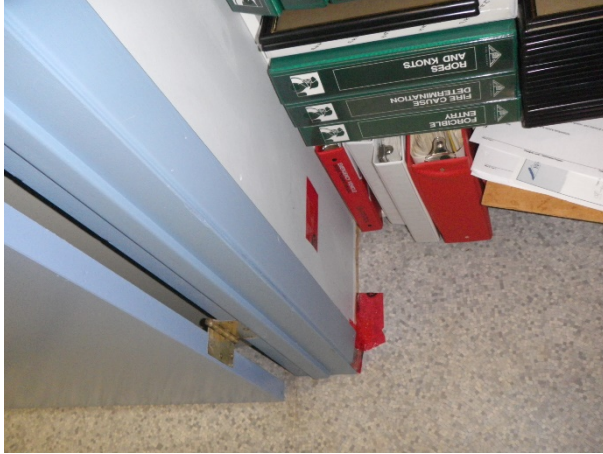
Figure 88: Sample B, 2nd floor training room, A/V room north wall blue wood trim paint

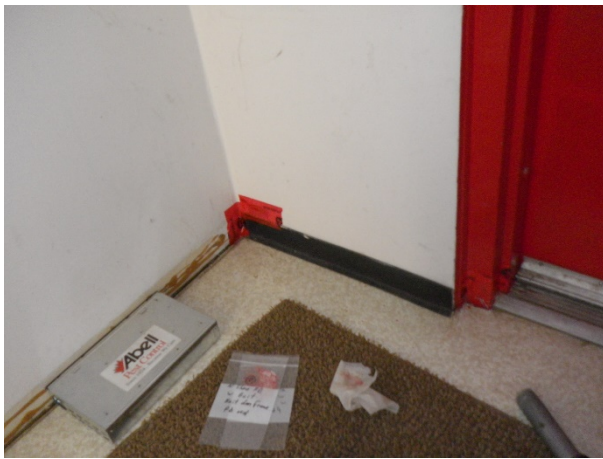
Figure 89: Sample C, 2nd floor west exit west wall white wall paint

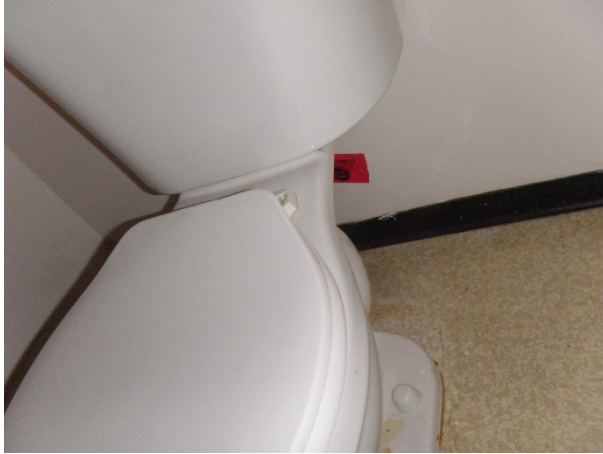
Figure 91: Sample E, 2nd floor men's washroom behind toilet east wall, beige wall paint

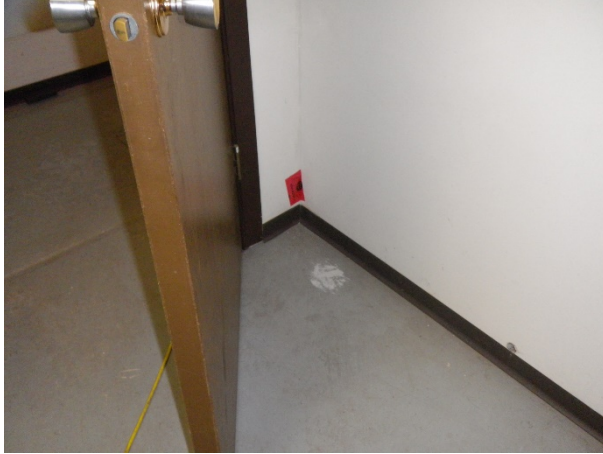
**Figure 96: Sample D, main floor men's washroom, NE corner floor, grey floor paint on concrete (2510 ppm)**

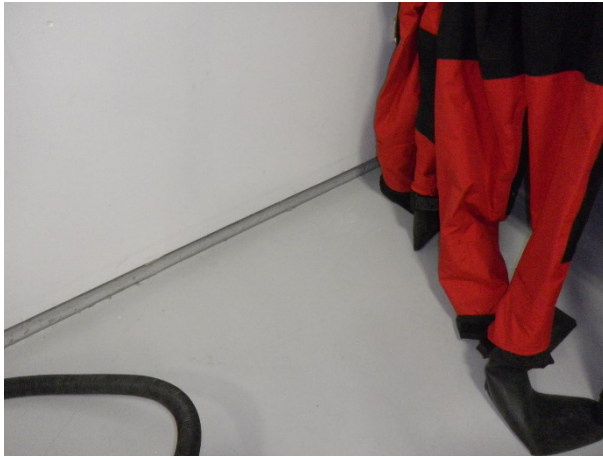
Figure 99: Sample A, main floor main bay, SW corner grey floor paint on concrete

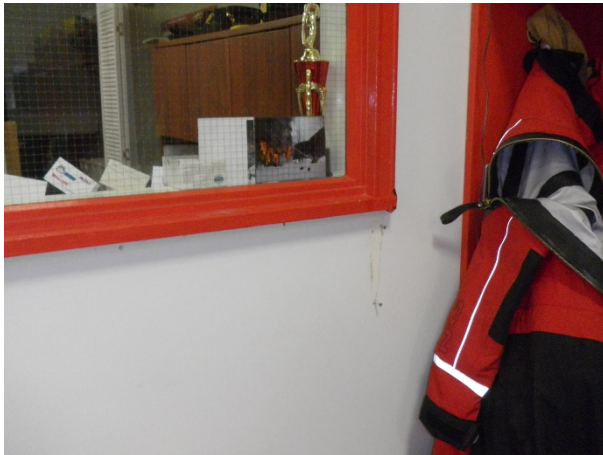
Figure 100: Sample B, main floor main bay, SW corner white paint on wall

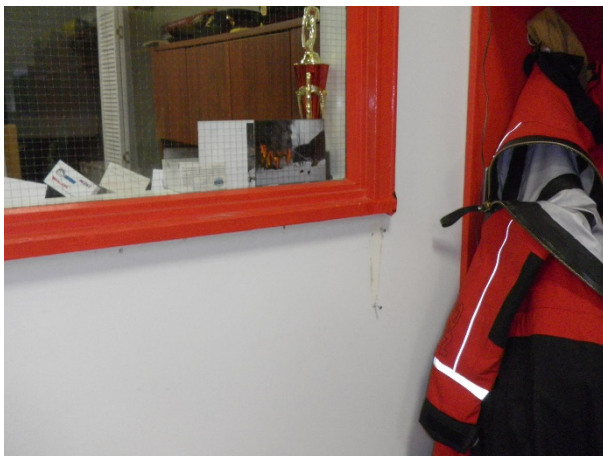
Figure 101: Sample C, main floor main bay, SW corner, red paint on window trim (9280 ppm)

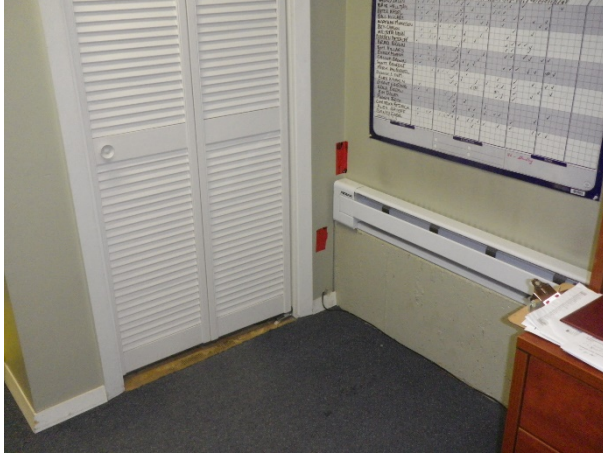
Figure 102: Sample D, main floor office, SW corner olive paint on wall

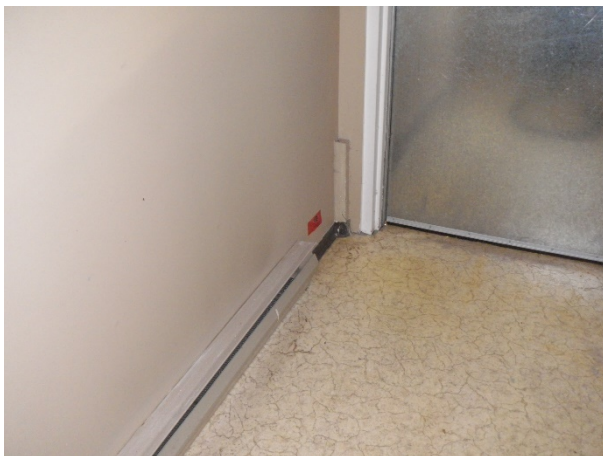
Figure 104: Sample F, main floor hallway by east exit, brown paint on wall

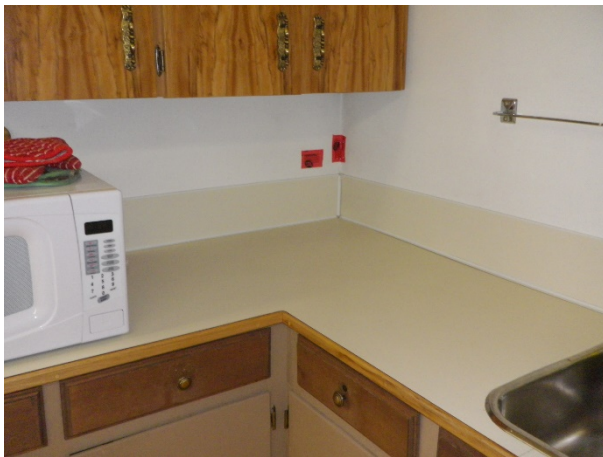
Figure 106: Sample H, 2nd floor kitchen, SE corner off white paint on wall

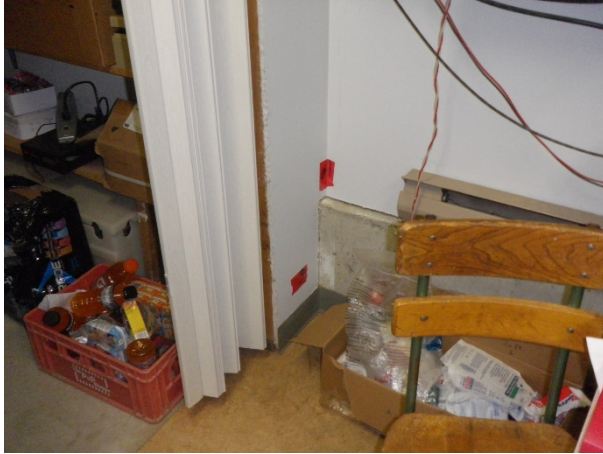
Figure 107: Sample A, main floor office, SW corner, light blue paint on wall

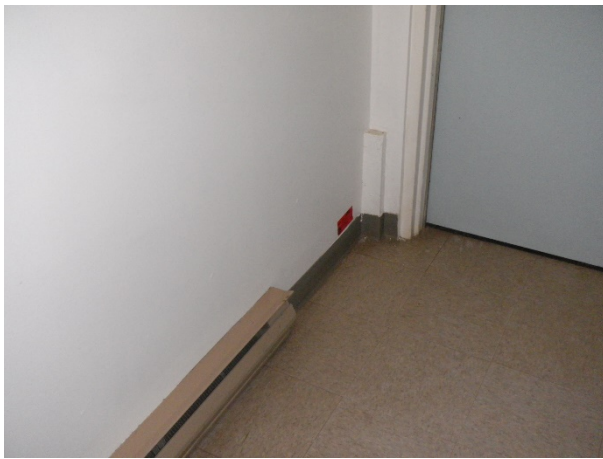
Figure 108: Sample B, main floor hallway, west wall by exit white paint on wall

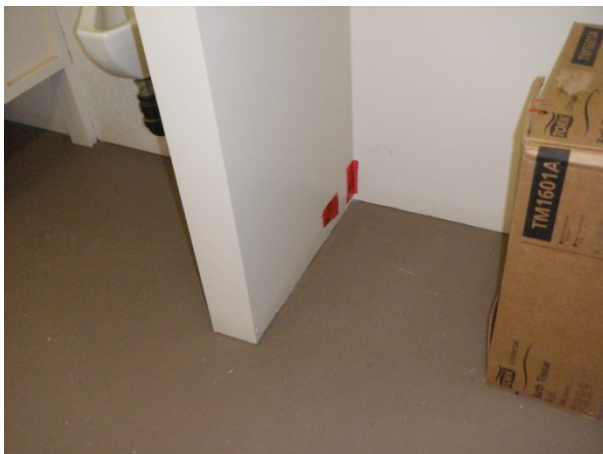
Figure 109: Sample C, main floor men's washroom south wall beige paint on wall

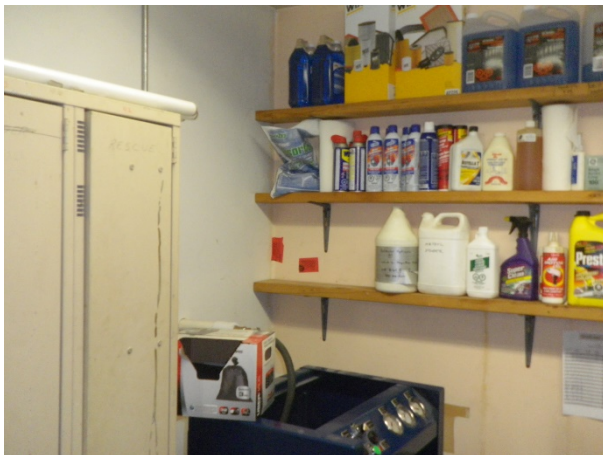
Figure 111: Sample E, main floor workshop, SW corner, salmon paint on wall

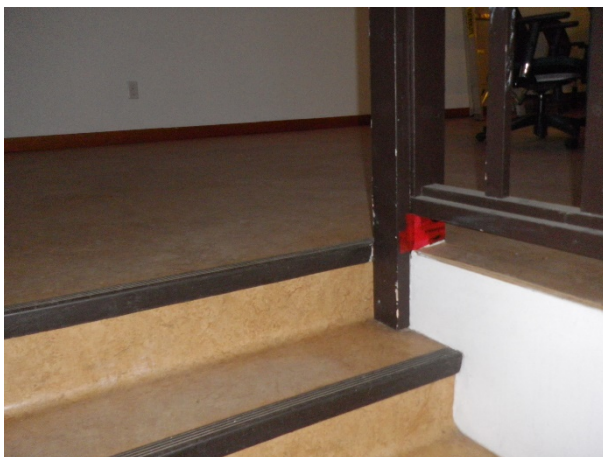
Figure 112: Sample F, 2nd floor stair handrail post, dark brown paint on wood post

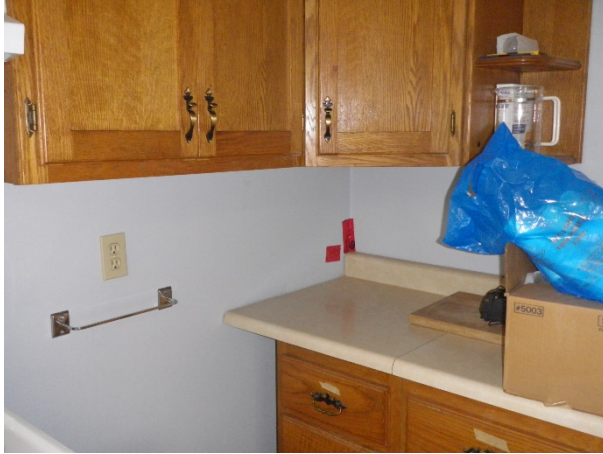
Figure 113: Sample G, 2nd floor kitchen, SW corner light blue paint on wall

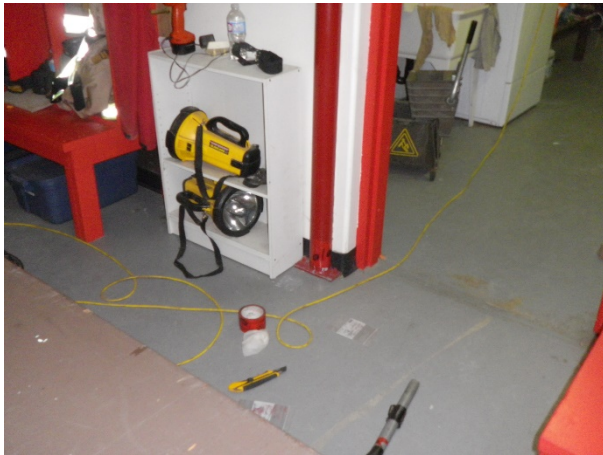
Figure 114: Sample A, main bay, SW corner grey floor paint on concrete

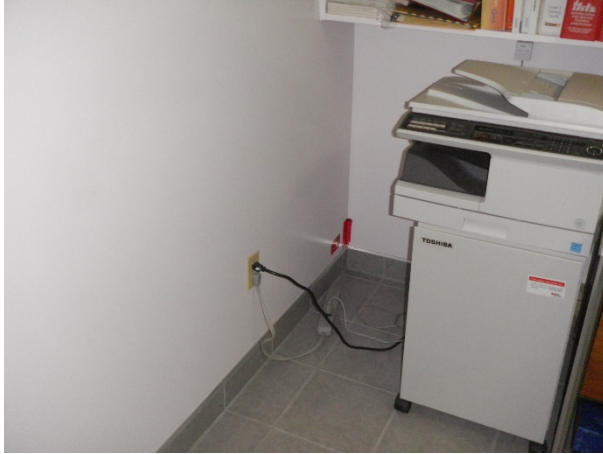
Figure 116: Sample C, main floor office, NE corner pink paint on wall

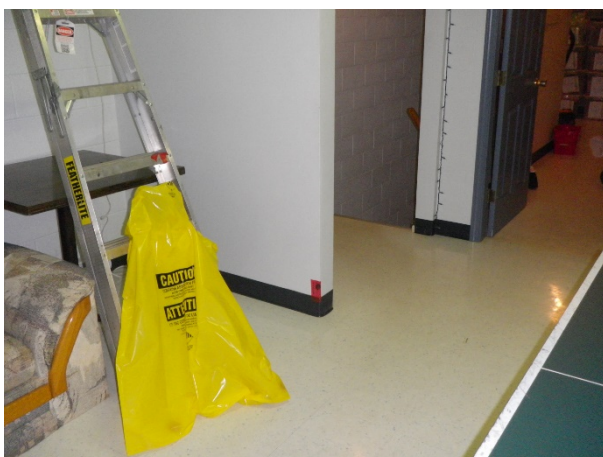
Figure 118: Sample E, 2nd floor recreation room, SE corner, white paint on wall
