### TARRY'S FIRE HALL WINDOW REPLACEMENT PROJECT PRJ24054

#### ADDENDUM NO. 1

# 24017-TARRYS FIRE HALL

ASBESTOS, LEAD AND OTHER IDENTIFIED HAZARDS

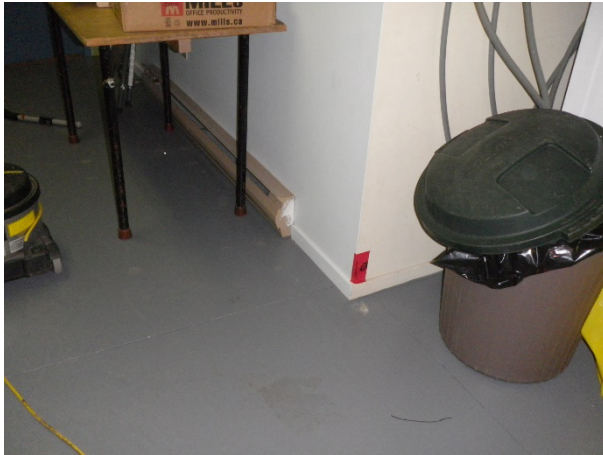
Figure 119: Sample A, main floor workshop middle corner, grey paint on concrete floor

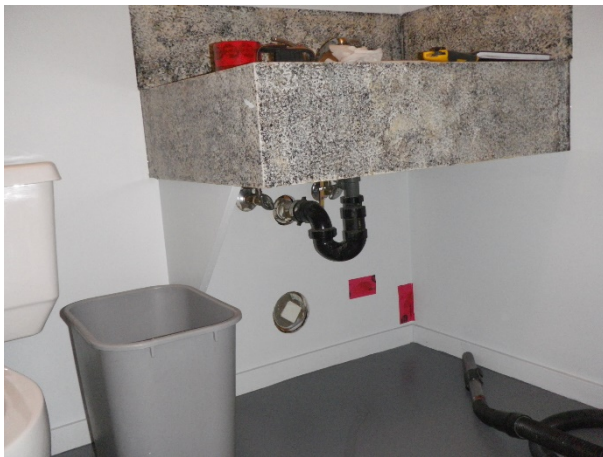
Figure 120: Sample B, main floor south washroom, north wall middle, light blue paint on wall

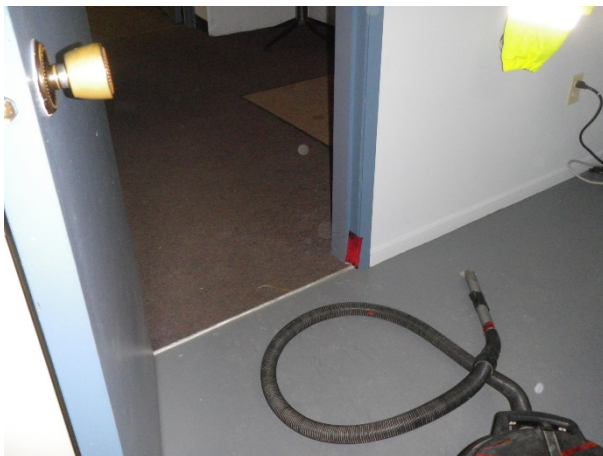
Figure 121: Sample C, main floor office door trim, dark blue paint on wood door trim

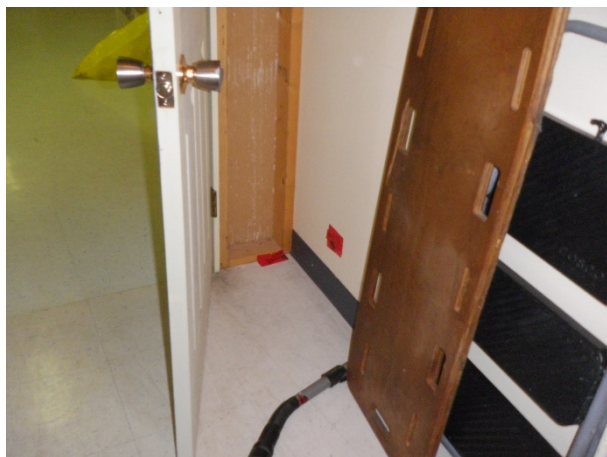
Figure 122: Sample D, 2nd floor storage room, NW corner at door, beige paint on wall
