### TARRY'S FIRE HALL WINDOW REPLACEMENT PROJECT PRJ24054

#### ADDENDUM NO. 1

# 24017-TARRYS FIRE HALL

ASBESTOS, LEAD AND OTHER IDENTIFIED HAZARDS

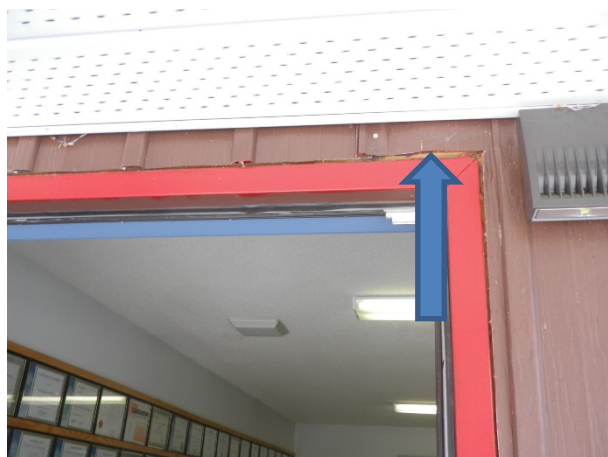
Figure 6: Sample 8, 2nd floor, NW exit, exterior above door behind siding, construction paper

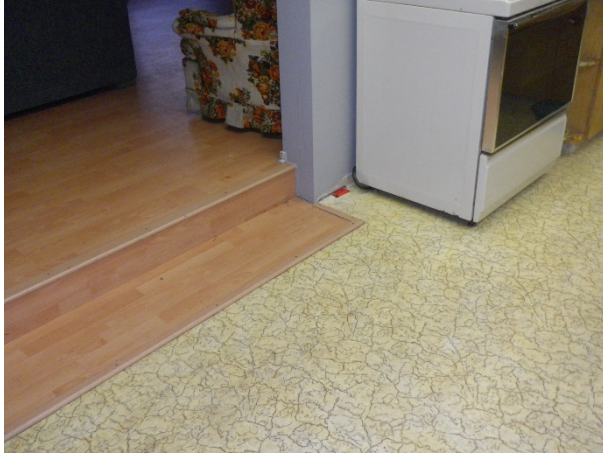
Figure 24: Sample 10, 2nd floor, kitchen, south wall at entry sheet vinyl flooring

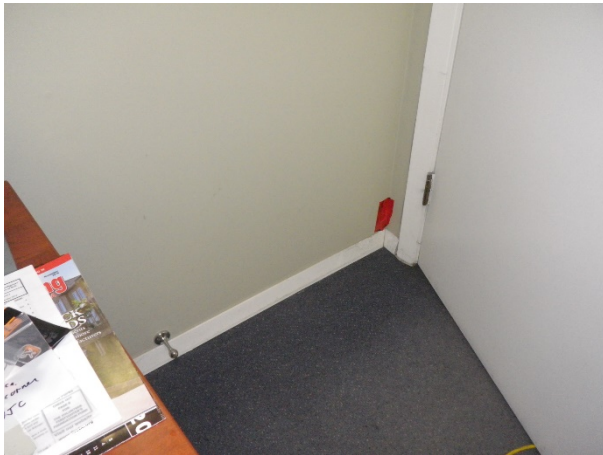
Figure 30: Sample 5, main floor office NE corner, drywall joint compound

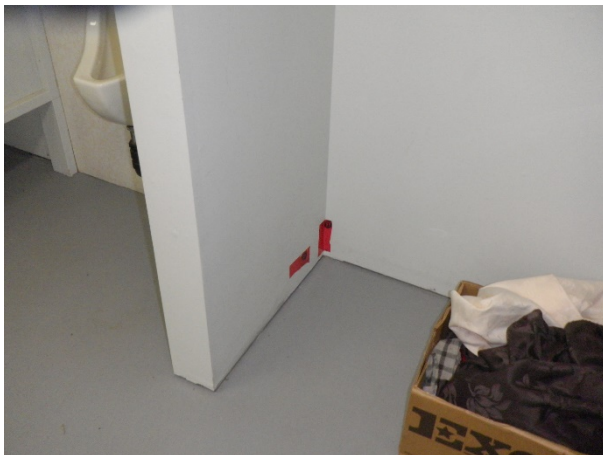
Figure 33: Sample 8, main floor men's washroom south wall, drywall joint compound

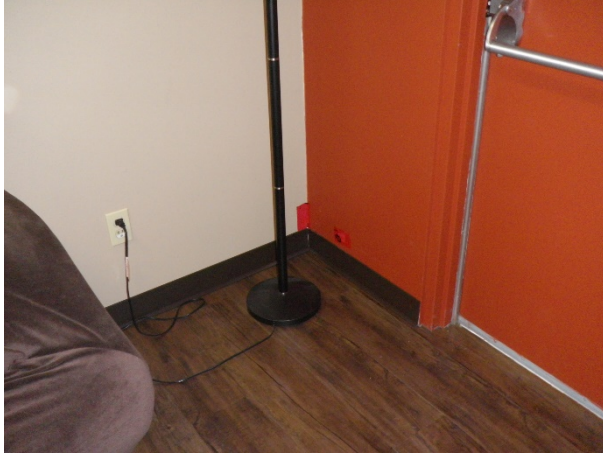
Figure 35: Sample 10, 2nd floor family room SE corner, drywall joint compound

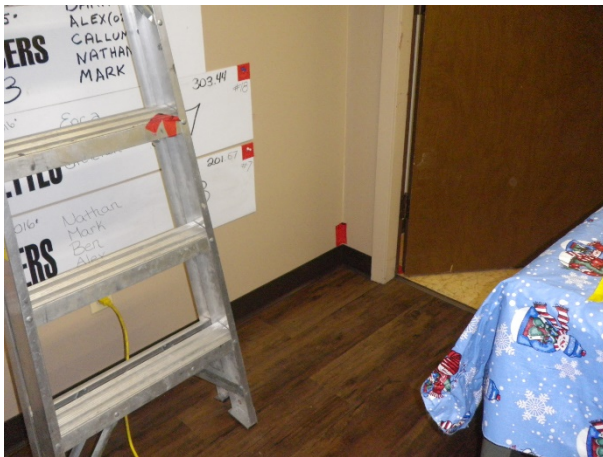
Figure 36: Sample 11, 2nd floor family room, NE corner, drywall joint compound.

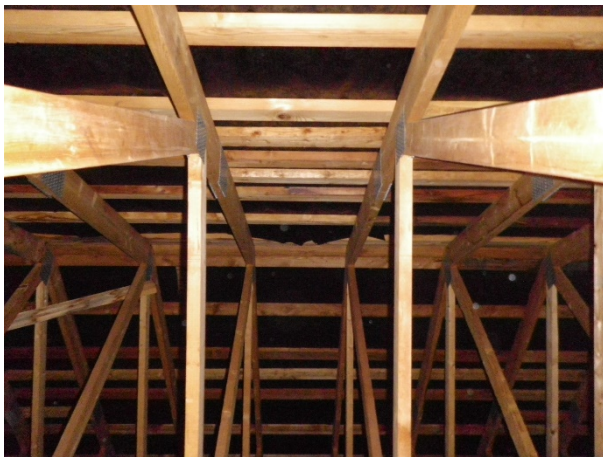
Figure 39: Sample 14, attic at gable peak, construction paper

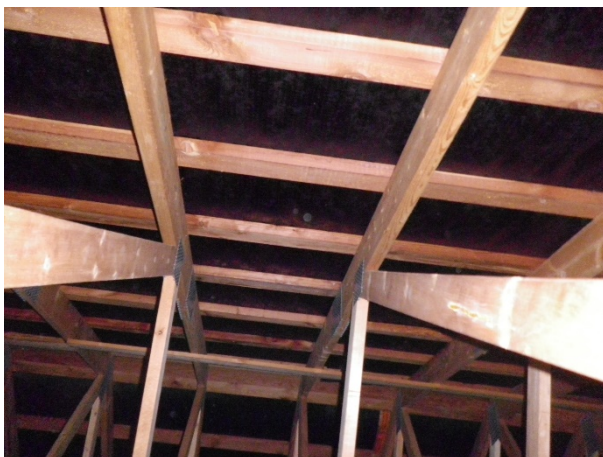
Figure 55: Sample 16, attic at peak, construction paper

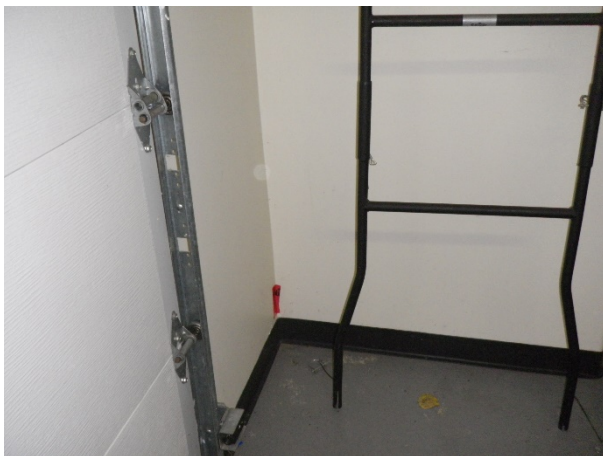
Figure 58: Sample 3, main floor small bay, SE corner, drywall joint compound

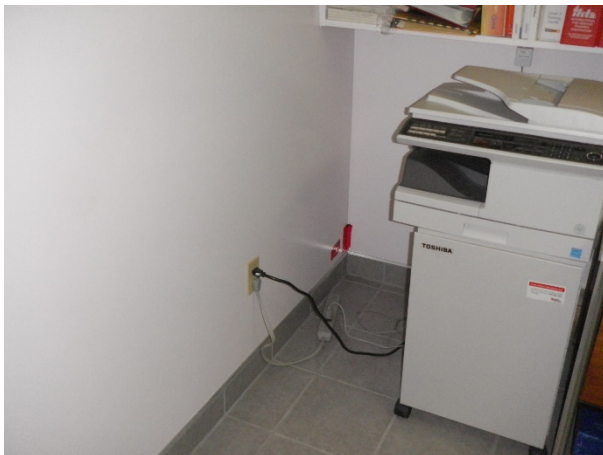
Figure 60: Sample 5, main floor office, NE corner, drywall joint compound

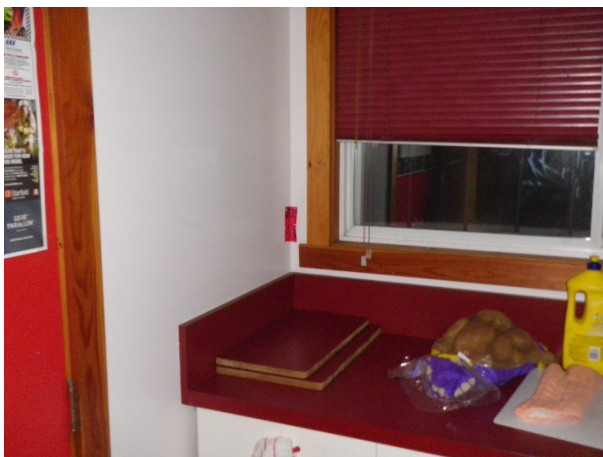
Figure 67: Sample 12, 2nd floor, kitchen, SE corner, drywall joint compound

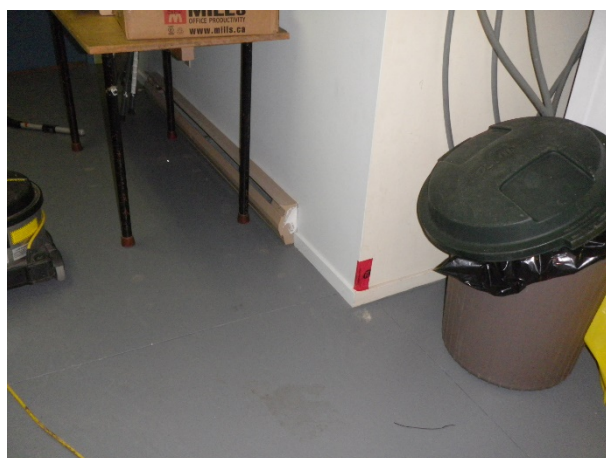
**Figure 73: Sample 3, main floor workshop middle corner, drywall joint compound**

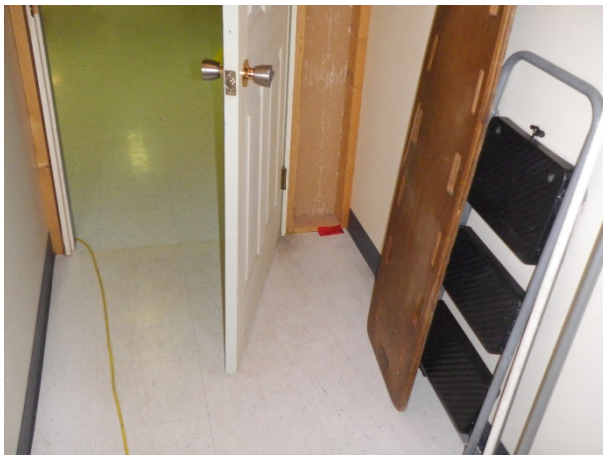
Figure 84: Sample 12, 2nd floor storage, NW corner vinyl floor tile

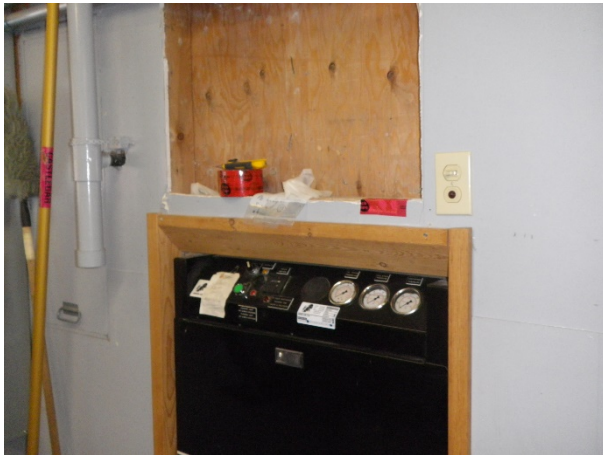
Figure 92: Sample F, main floor, east entry at compressor, grey wall paint

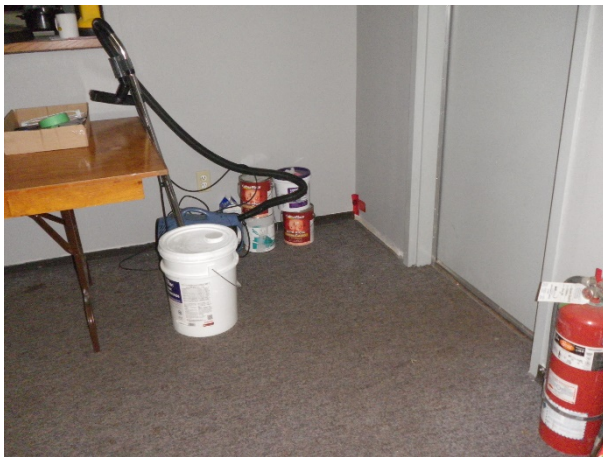
**Figure 97: Sample E, 2nd floor exercise room, SW corner wall grey wall paint**

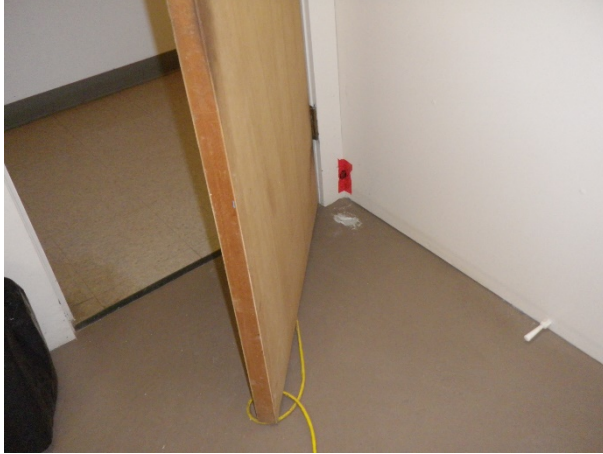
Figure 110: Sample D, main floor men' washroom, NE corner brown floor paint

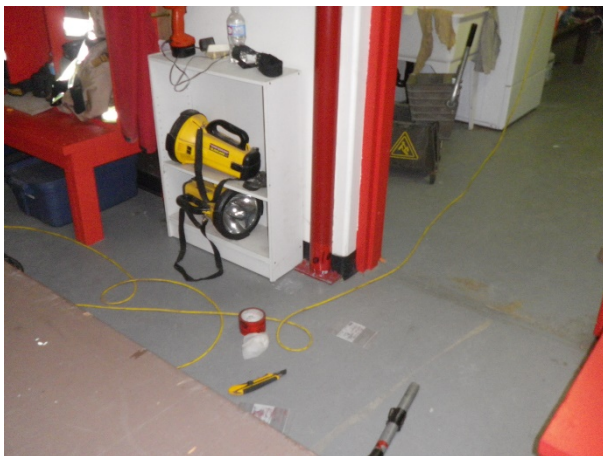
Figure 115: Sample B, main bay, SW corner red paint on post
